**PRELIMINARY GEOLOGIC AND GEOTECHNICAL INVESTIGATION  
PROPOSED 9-LOT RESIDENTIAL SUBDIVISION  
APNs 166-200-032 AND 166-210-008  
GLORIA TERRACE  
LAFAYETTE, CALIFORNIA**

**Project No. 1668  
February 4, 2016**

Subject: Proposed 9-Lot Residential Subdivision  
APNs 166-200-032 and 166-210-008  
Gloria Terrace  
Lafayette, California

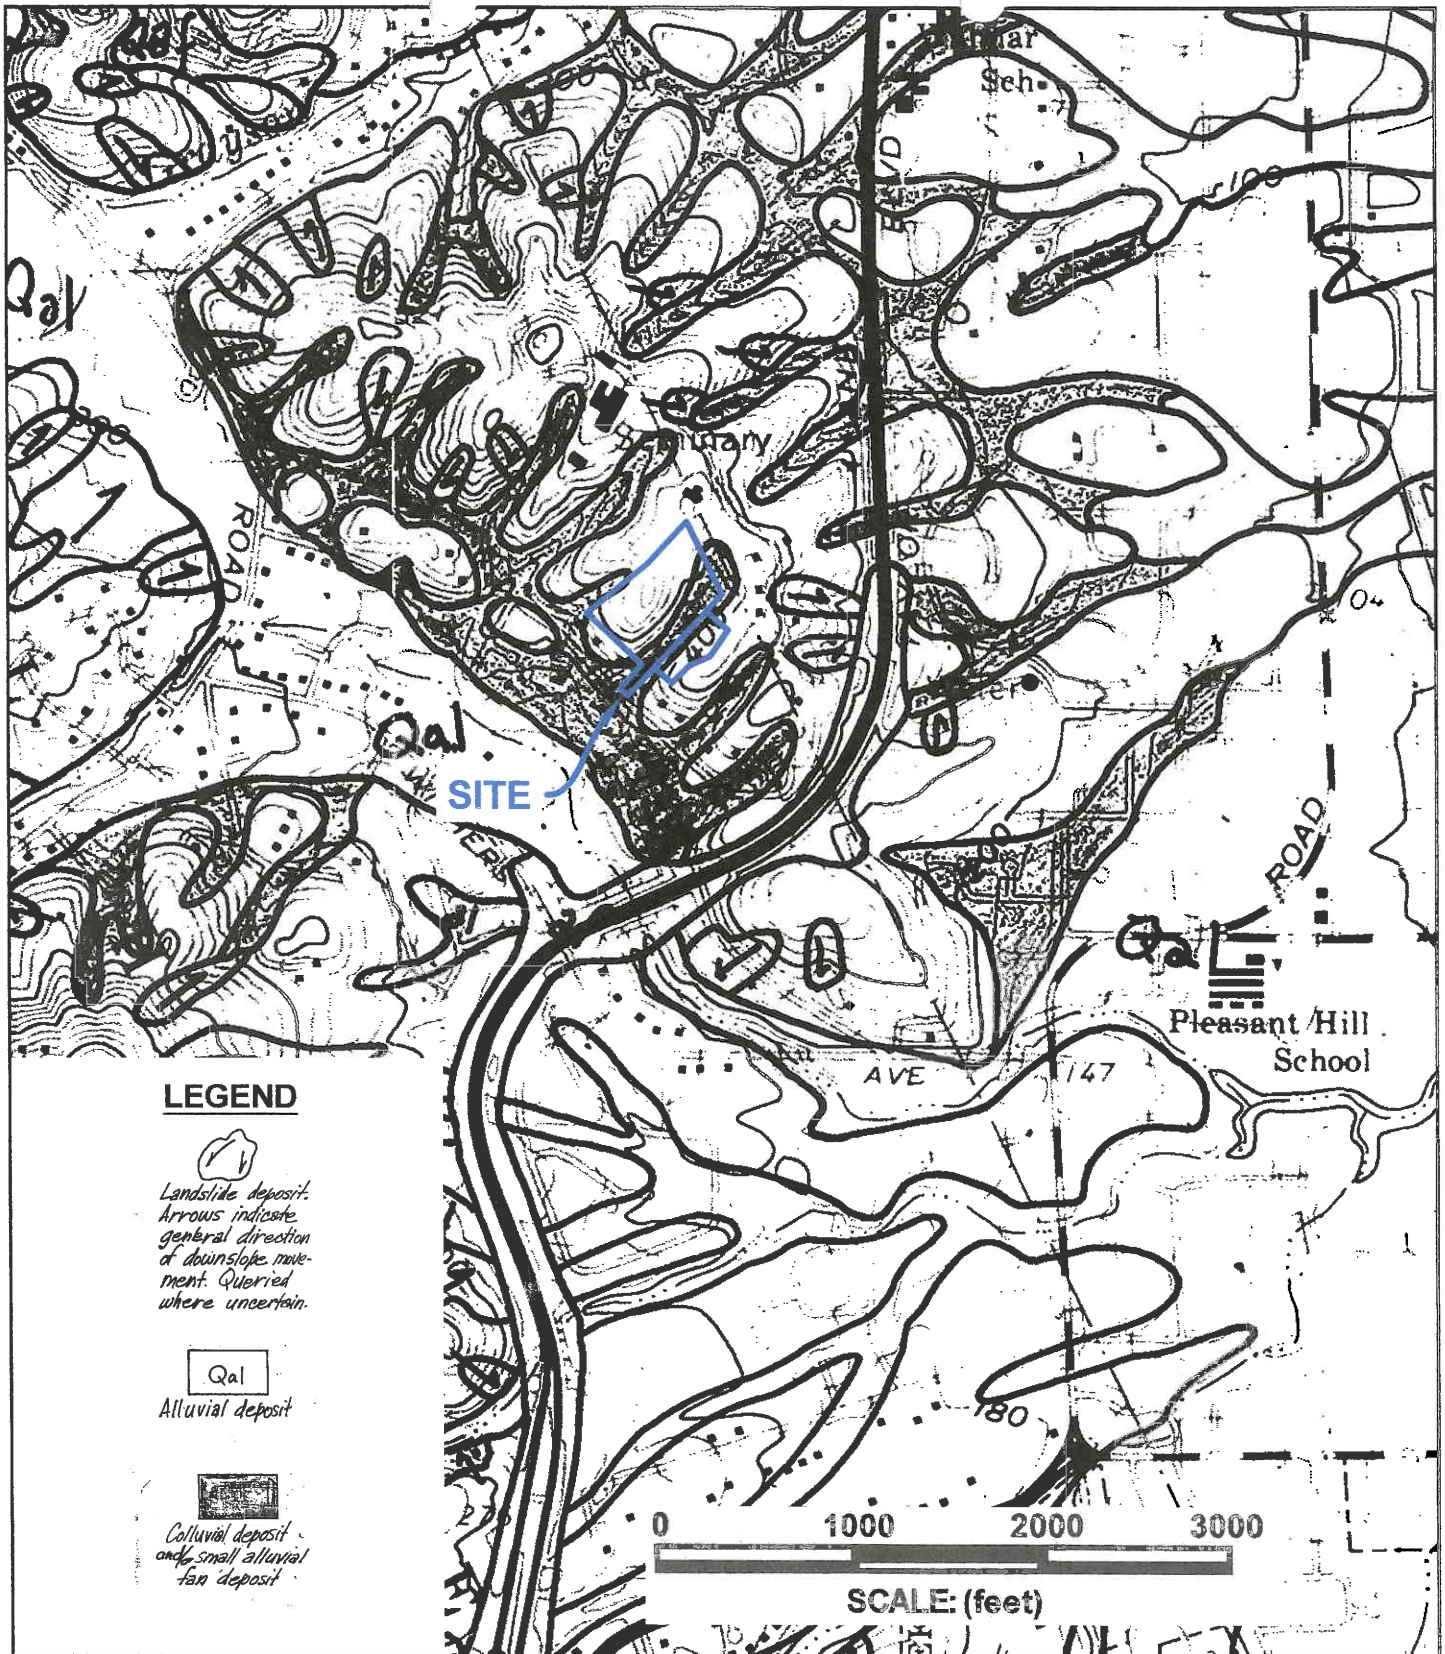
**LANDSLIDE MAP (NILSEN)**

Nilsen's map shows that colluvial deposits are present in the topographic swale located at the base of the southeast-facing slope. Both maps indicate that no slides were mapped on or near the vicinity of the site.

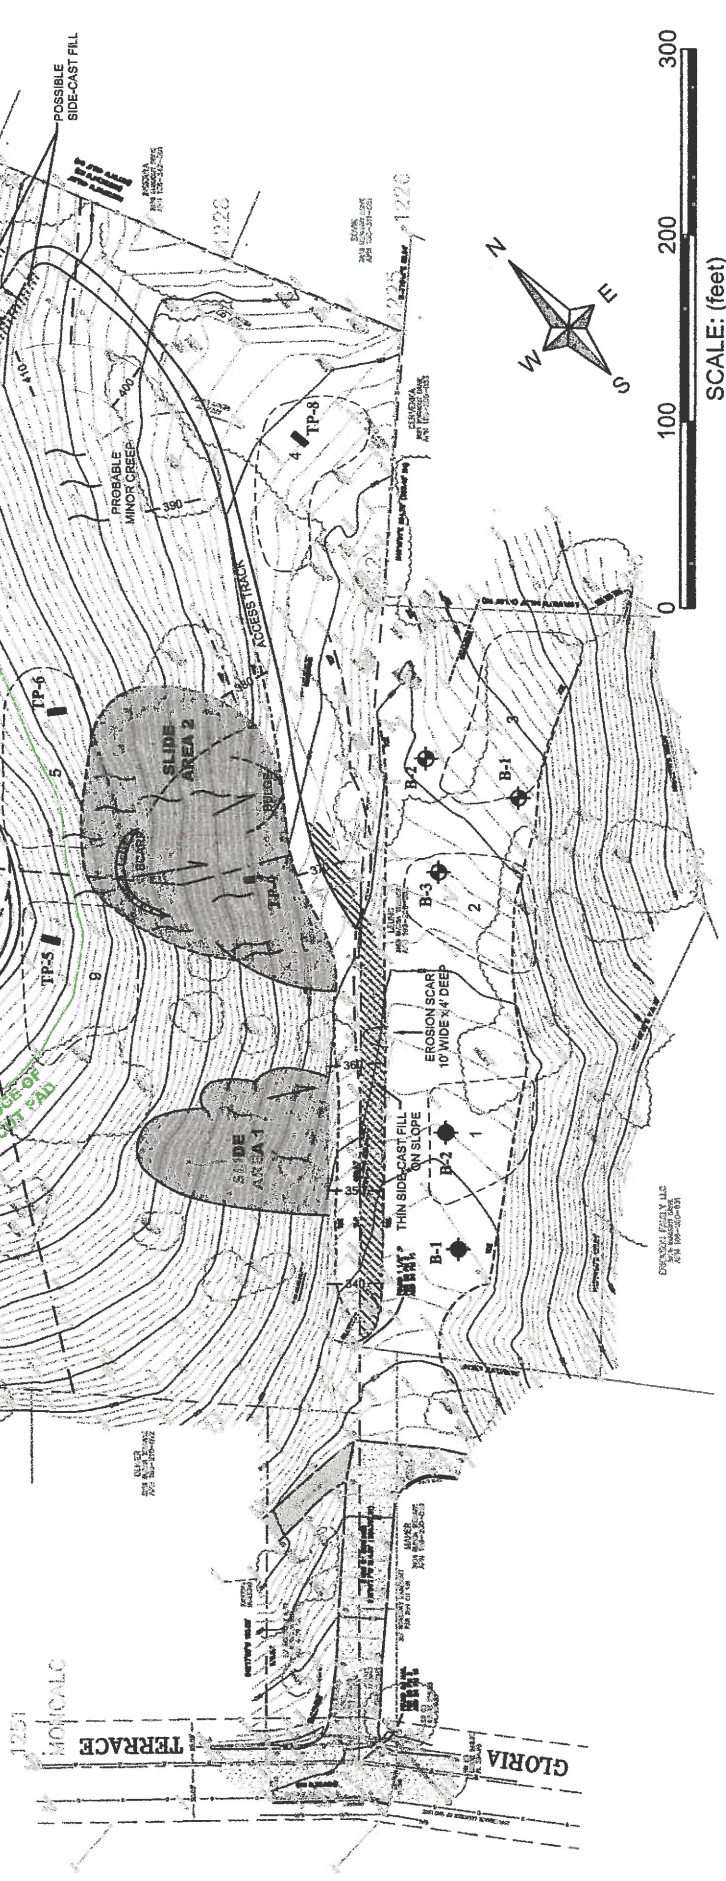
**SITE PLAN AND SURFICIAL  
 FEATURES MAP**

Much of the ground surface in the center of the area is lumpy and irregular, indicating that the soil has been slumping and/or creeping downslope (see Figure 7). A distinct arcuate scar about 1 foot high is located slightly upslope of a large tree, while lumps and bulges are located further downslope. We saw no open cracks and the scarps and lumps all appeared to be rounded, so we infer that the soil movement is at least several years old. A smaller area of soil creep and possible minor slumping is present in the southern portion of the slope. A steep-sided, subtle swale can be seen, and the surface is somewhat irregular and lumpy. Test Pit TP-9 found that the soil is only about 1 foot thick, and the bedrock is composed of hard, fractured sandstone. We also found a large open fracture about 1 foot wide, at a depth of 3 feet into the bedrock. This fracture was filled with soft damp soil. We expect that this is an old animal burrow, but there is a possibility that this open fracture could be related to the recent soil movement. Because of the steep slopes and wet soil, the excavator was not able to dig additional test pits in the unstable area.

The steepest slopes on the property occur below Lots 5 and 9, and these slopes contain clear evidence of recent shallow slumping and soil creep. Our preliminary observations suggest that there is a moderate to high risk that future movement could occur in the thin soil mantling this slope and that this movement could affect the houses above and the driveway below. More detailed subsurface exploration and analysis should be done to evaluate the risk of future soil movement on this portion of the slope. It is possible that earthwork or other methods may be needed for mitigating this hazard.

Probable Unstable Soil Areas (Based on Field Reconnaissance MCC, January 2016)

Proposed Driveway: At the time the grading/improvement plans become available additional subsurface exploration may need to be performed on the slope above the driveway where the probable unstable areas are mapped on Figure 7 on the downhill side of Lots 5 and 9. The report should include recommendations for mitigating the hazard against the potential of soil creep or slumps that may affect the driveway and the houses above.
