PHYSICAL NEEDS ASSESSMENT

Las Deltas Public Housing – 49 Duplexes
1601 North Jade Street
North Richmond, California 94801

EMG Project Number:
132461.18R000-003.052

Date of Report:
December 13, 2018

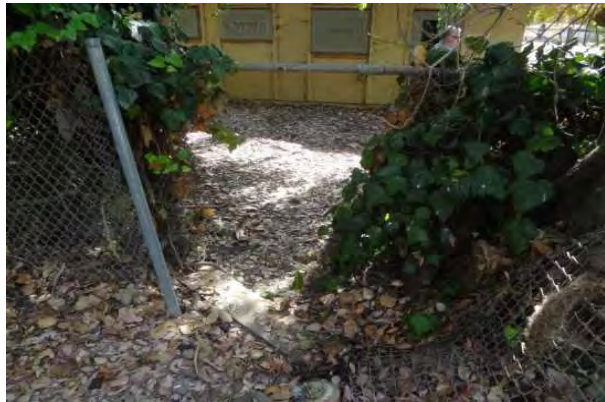
- The wrought iron site fencing has isolated areas of the fence that are bent or missing. Repair/replacement of some sections of fence, is required.

#10	DAMAGED FENCE
-----	---------------

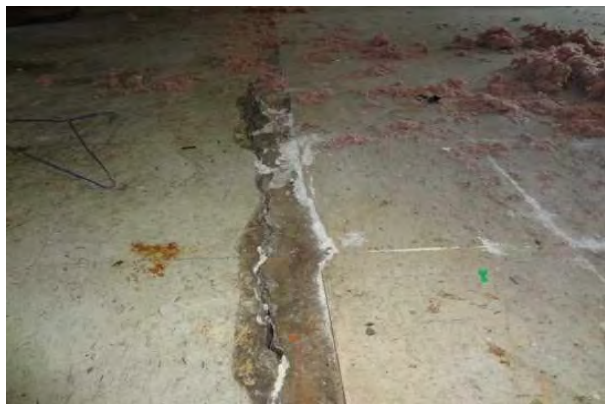
- Slabs in units 395 and 398 were observed to be cracked in the living rooms. A professional engineer must be retained to analyze the existing conditions to determine if these cracks indicate structural failures, provide recommendations and, if necessary, estimate the scope and cost of any required repairs. The cost of this study is included in the cost tables.

- The foundations and footings cannot be directly observed. However, there are isolated areas of cracked slabs (living room floors of units 395 and 398). This condition typically indicates excessive settlement or other potential problems with the slab or foundation system. A Professional Engineer with specific expertise in structural design and construction in this geographical area must be retained to evaluate the structure and to provide remedial recommendations consistent with local regulatory and code requirements. Costs are included as part of section 1.2. A cost allowance to correct these conditions is included in the tables as part of this section.

#12	CRACKED INTERIOR SLAB
-----	-----------------------

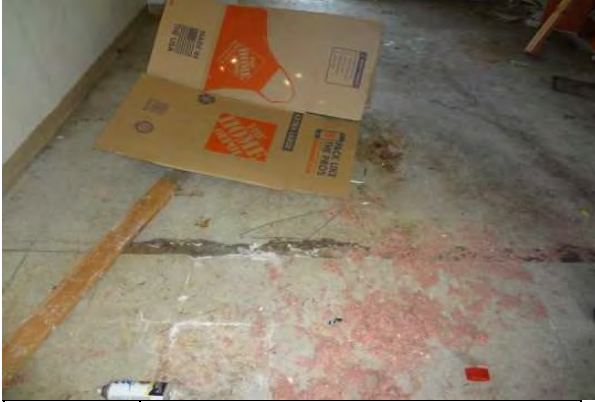
#13	CRACKED INTERIOR SLAB
-----	-----------------------

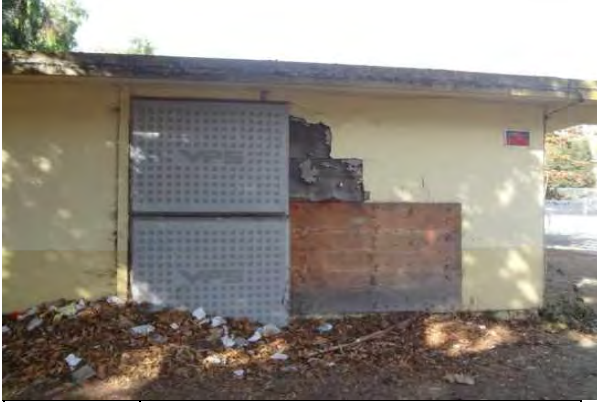
#19	DAMGED EXTERIOR STUCCO
-----	------------------------

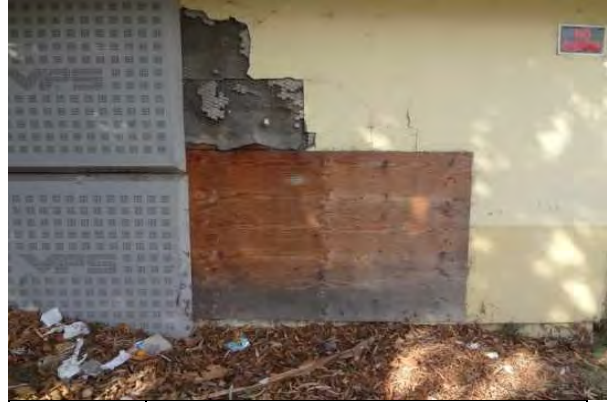
#20	DAMAGED EXTERIOR STUCCO
-----	-------------------------

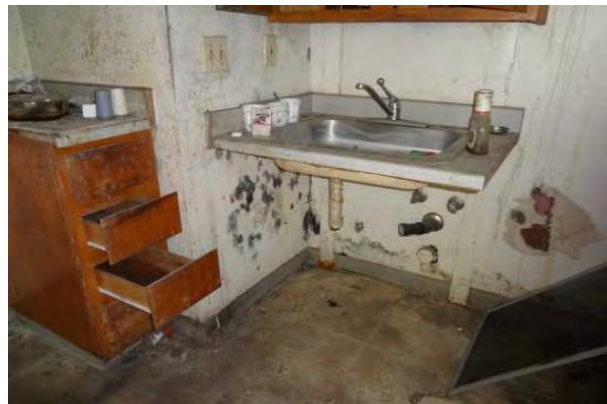
Areas of suspect mold growth, moisture, and water damage were observed along the drywall and flooring in the following areas:

The mold and moisture condition appears to be the result of damaged piping from scavengers stealing the copper distribution piping. A cost allowance to repair the affected areas of mold is included.

#46	MOLD/BIOLOGICAL GROWTH
-----	------------------------

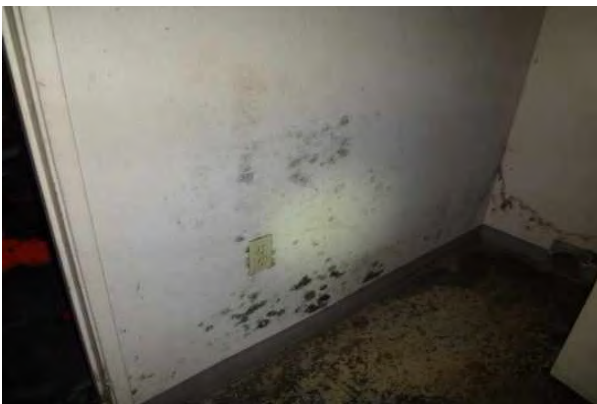
#47	MOLD/BIOLOGICAL GROWTH
-----	------------------------
