TP19-0036

July 3, 2019 (revised 10/25/19)

Re: Revised Arborist Report for 0 West Newell Avenue, Walnut Creek

TREE PROTECTION PLAN
By: Jennifer Tso
Certified Arborist #WE-10270A
Traverso Tree Service, Inc.
October 25, 2019
(drawn on proposed roadway access and utility plan)

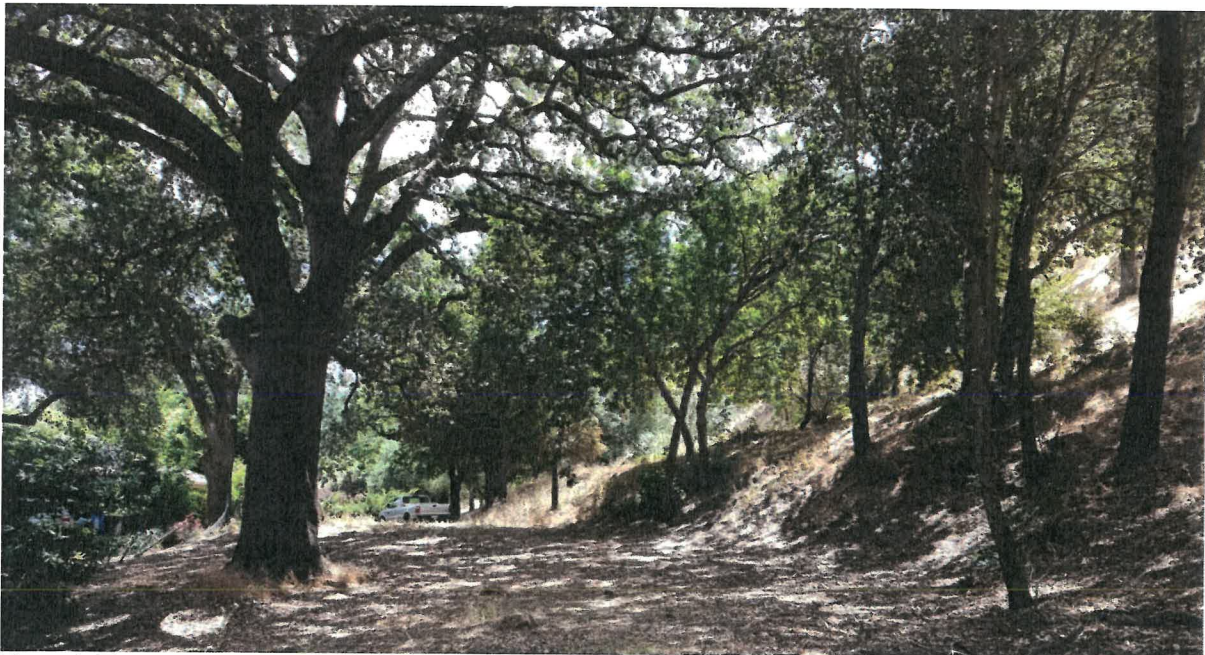
Figure 1. The property is heavily wooded and extends far up the hill off the right side of the photo. The three large oaks along the north property line (left) will be affected by the proposed construction.

The property is located at the end of W Newell Avenue, south of 2776 W Newell. The site is heavily wooded and extends uphill to the south (Figure 1). Overhead power lines extend along W Newell Avenue to the center of the property, where they change to a north-south orientation & connect to a power pole off Olympic Blvd. The hilly portion of the property, south of the utility easement, is essentially unusable due to the slope & utility restrictions. The proposed project will construct a single-family home on the property. The west run of the overhead power lines will also be undergrounded per PG&E requirements & to reduce fire risk.

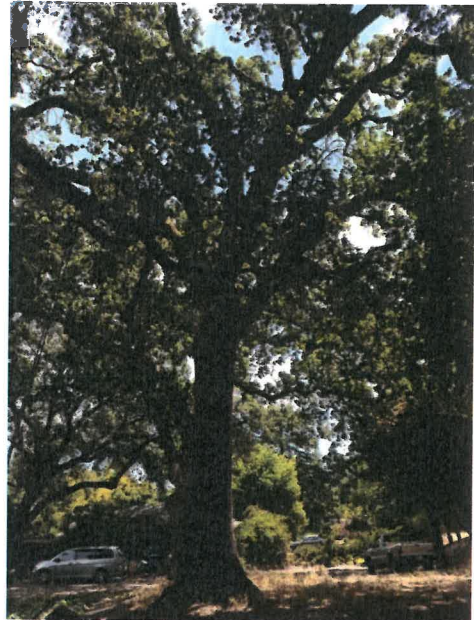
Figure 2. The largest oaks on the property (top #37, bottom #36) will be subjected to high encroachment & will need to be removed. The house location cannot be adjusted to save them, as the clearance required would unreasonably restrict development.

The trees on the property are mostly in good-fair health, with structures typical of trees growing in crowded woodland conditions. The feasible building area is limited by existing N-S & E-W utility easements, as well as the hillside south of the utility easement. Two large oaks (#36 & 37, Figure 2) are located along the north property line, in or surrounded by the proposed home. Unfortunately, although they are among the largest trees on the property, they cannot be saved without significantly restricting development.

- Remove trees #9-19, 21, 23-26, 31-33, 36 & 37 (21 trees).
- Mulch from tree removals may be spread out under the driplines of trees that will be retained, **keeping at least 12" away from the trunks.**
- Prior to construction or grading, contractor shall install **6' chain-link** fencing to construct a temporary Tree Protection Zone (TPZ) around each tree or grove of trees as indicated on the tree protection plan. Heavy duty orange poly fencing may be used west of the power lines; fencing shall be securely attached to **metal stakes spaced 6' apart.**
- TPZ fencing shall remain in an upright sturdy manner from the start of grading until the completion of construction. Fencing shall not be adjusted or removed without consulting the project arborist (PA).

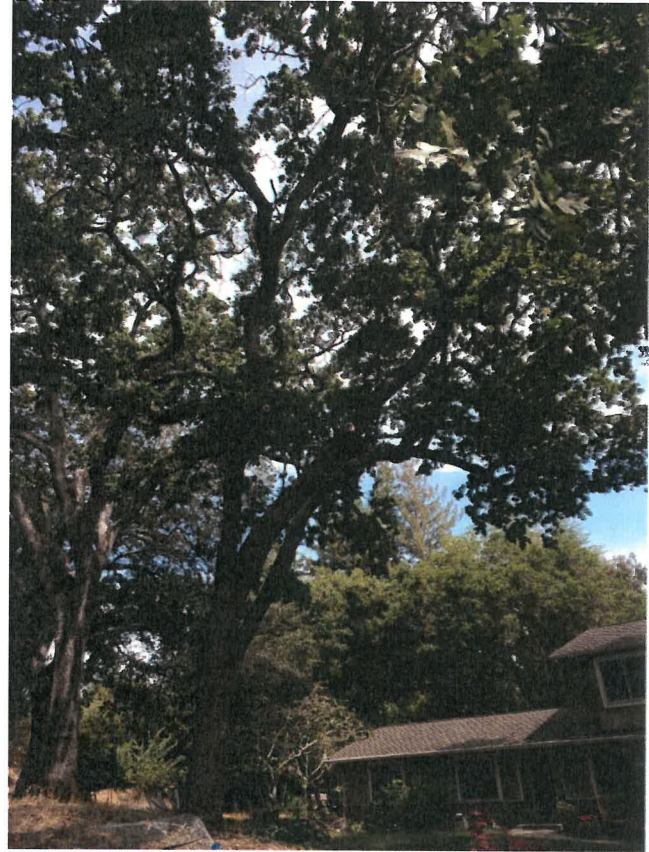
The driplines of three of the neighbor's trees will be encroached. Oak #38 is located on the property line, with most of its trunk on the adjacent property (Figure 3). Proposed improvements within its dripline include a retaining wall, to be constructed on 6' deep piers that begin 4' from its trunk. A minimum of 6" of fill will also be required to maintain drainage within the property. The three closest piers will be located within the structural root plate (SRP) of the oak, which is the area proximal to the trunk where the largest diameter roots are found. These structural roots are responsible for anchoring & supporting the tree, and removal of structural roots can compromise its stability. I recommend hand digging the upper 3' of each pier within 15' of the tree, so the pier locations can be adjusted in case they are centered over significant-sized roots. Additionally, a minimum of 6" of fill is required to maintain drainage within property lines. Fill soil placed over roots increases the distance that oxygen & water must travel to reach the roots, which can have a negative impact on a tree's health. Fill placed against the trunk, especially on native oaks, can create a moist environment favorable for wood decay fungi. Since the fill is not intended to support structures or hardscape, I recommend not compacting the fill soil, and pulling it at least 12" from the base of the tree.

Figure 3. To reduce encroachment, proposed grading & footing excavation shall be done by hand within 15'-20' of tree #38.

- **Footings of the proposed retaining wall within 15' of tree #38 shall be dug by hand for the top 3' of soil.** Project arborist (PA) shall be consulted for recommendations if roots $\geq 2"$ in diameter are encountered; footings shall be adjusted to save large roots.

- Fill/grading shall be done by hand within 20' of tree #38 with minimal compaction. Keep fill at least 12" clear of its trunk.
- Arborist shall be on-site during excavation for upper retaining wall by tree #20. Roots $\geq 2"$ diameter shall be cleanly pruned, covered, and kept moist till backfilled.
