**INSPECTION OF DAM AND RESERVOIR IN CERTIFIED STATUS**

Name of Dam Los Vaqueros Dam No. 1019-003 County Contra Costa  
Type of Dam Earth fill Type of Spillway Concrete ogee and chute  
Water is 7 feet below spillway crest and 21 feet below dam crest.

Name of Dam Los Vaqueros

Date of Inspection 10/31/2018

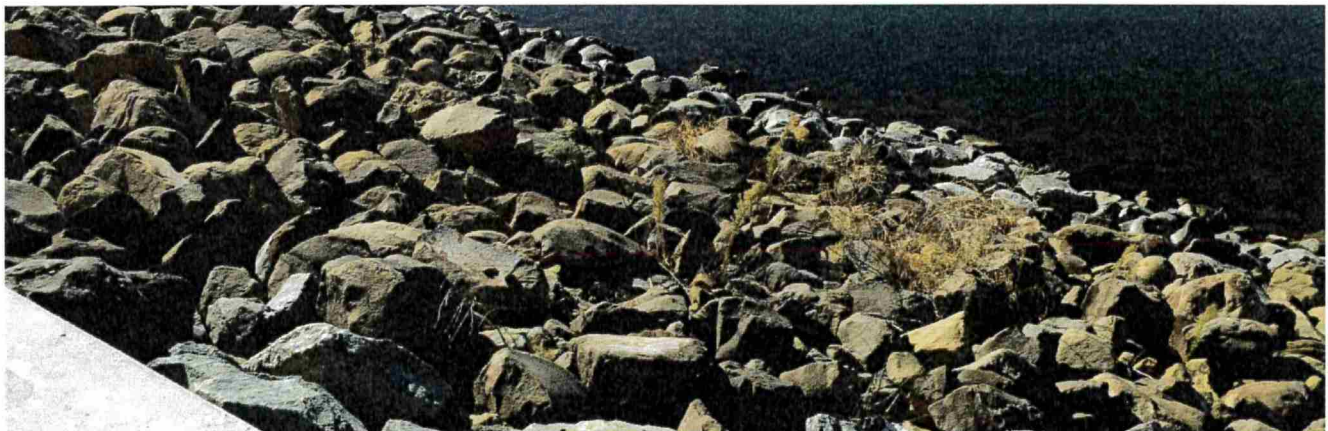
The visible portion of the riprap-covered upstream slope of the dam appeared to be satisfactory with mild sparse vegetation and debris, and no signs of slope instability (Photo 1). Upstream vegetation should be monitored to ensure no perennial growth occurs. The downstream slope of the dam contained numerous visible animal burrows, and areas of mild to moderate vegetation obstructing inspection (Photo 2). Woody vegetation on the downstream slope needs to be removed. The dense grass on the downstream face prevents adequate assessment of the magnitude of animal burrows and possible localized depressions. The two surficial slumps previously reported were repaired, and hydroseed was recently placed (Photo 3). The rock fill against the lower right abutment appeared to be satisfactory.

Photo 1 – Upstream rip-rap slope in satisfactory condition with mild vegetation.

Vegetation on upstream slope was mild and sparse and should be monitored to ensure no woody vegetation occurs.

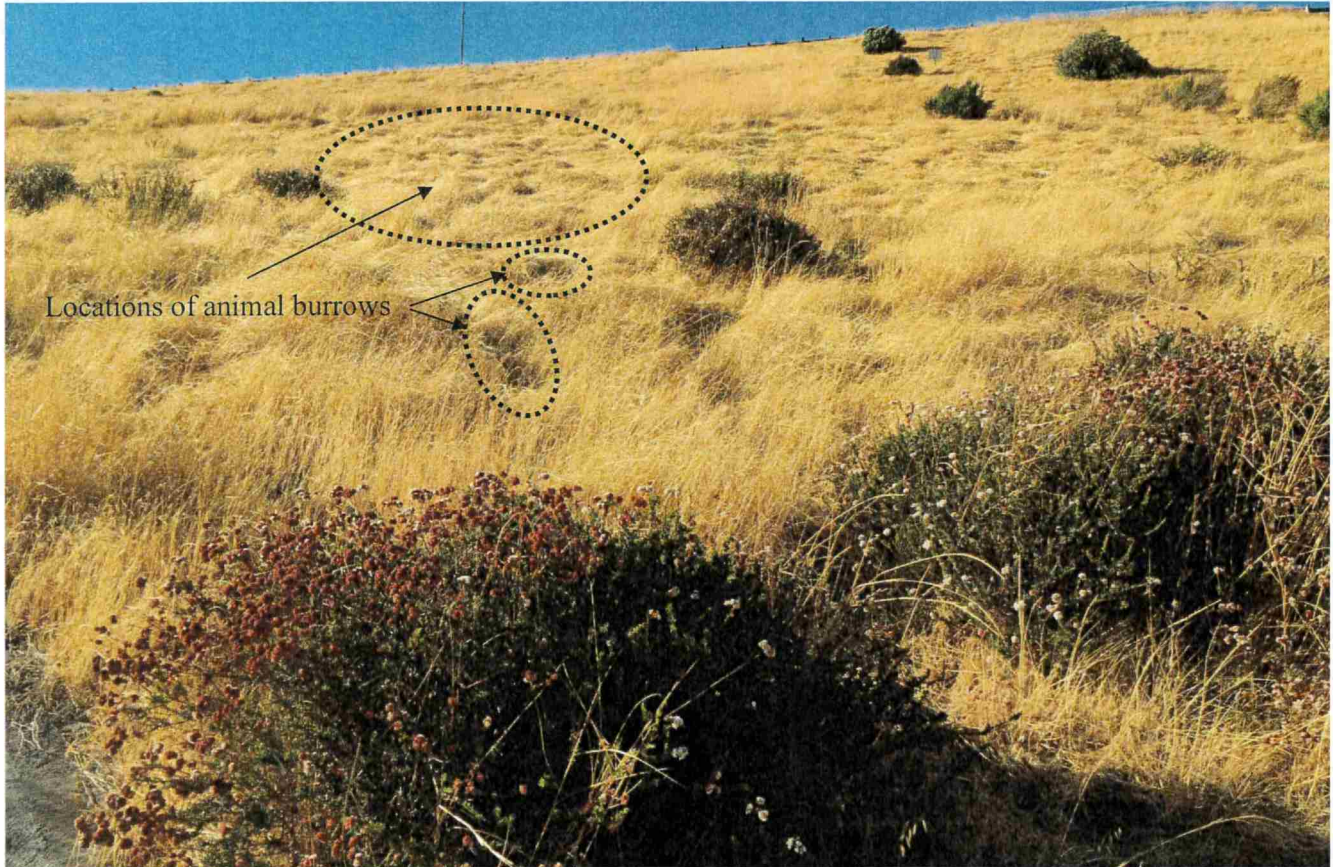
Photo 2 – View of downstream slope taken from V-channel on right side of dam showing slope vegetation and animal burrows.

Woody vegetation on the downstream slope needs to be removed. The dense grass on the downstream face prevents adequate assessment of the magnitude of animal burrows and localized depressions. The grass needs to be mowed periodically, and the owner needs to inspect the downstream face for animal burrows and localized depressions.

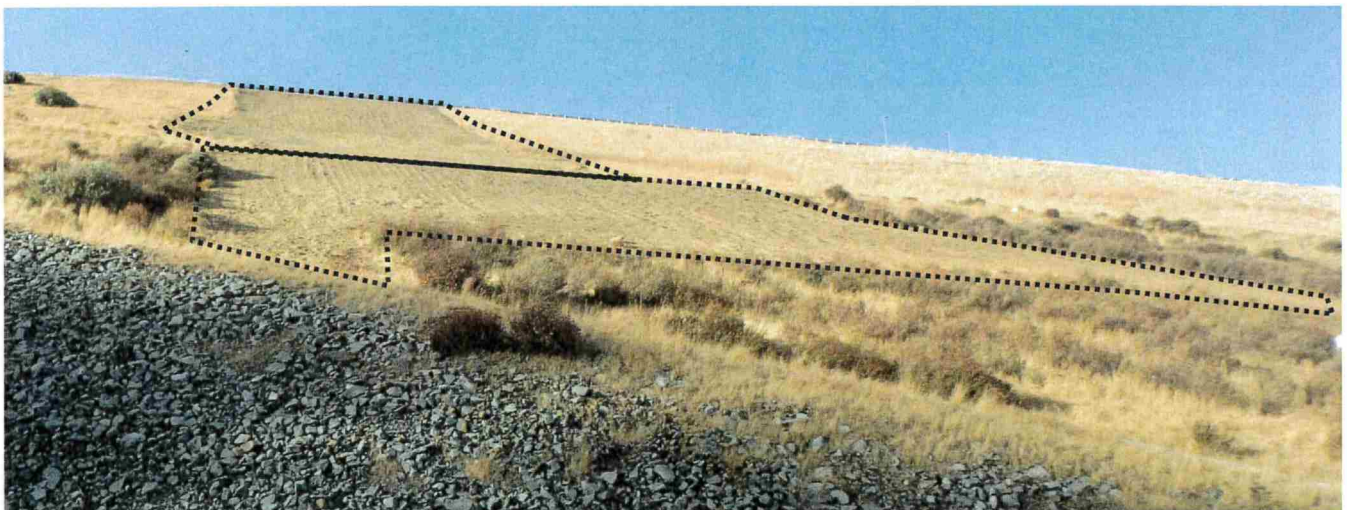
The two surficial slumps on the downstream face of the dam were repaired and appeared satisfactory.

Photo 3 – Two repaired surficial slumps on downstream slope.

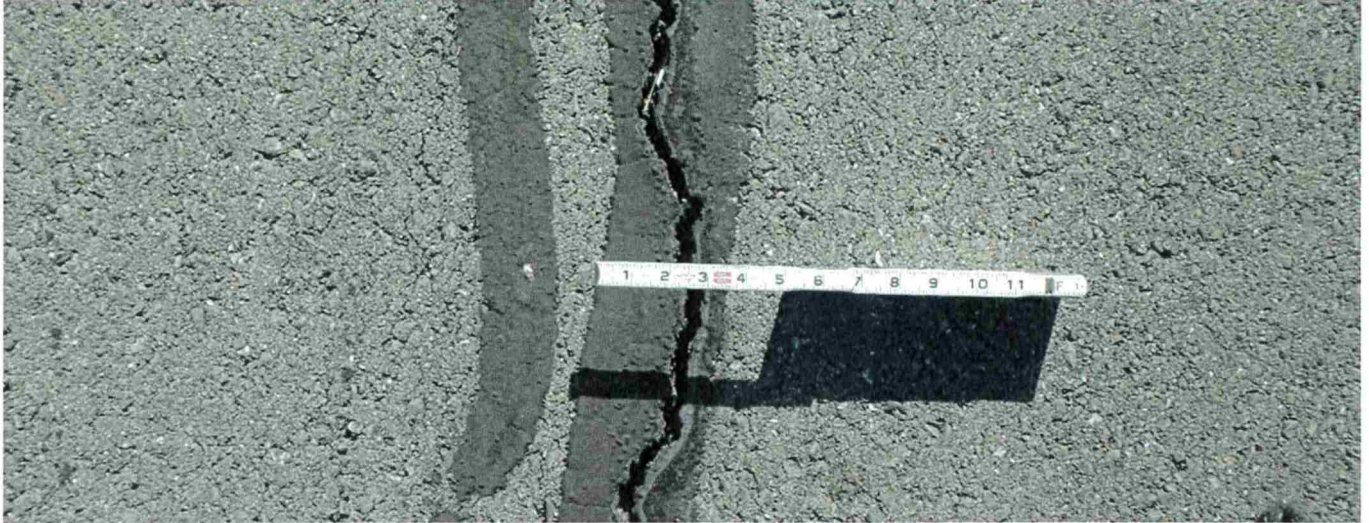
Longitudinal cracking was observed along the paved asphalt and concrete covered portion of the crest right of the spillway bridge. The asphalt cracking (approximately 120-foot-long) was previously patched in some locations, but is now open up to 1/2-inch-wide toward the center of the cracking, and is propagating longitudinally (Photo 4). The concrete crack (approximately 15-foot-long) was surficial (<1/8-inch-wide), but only 20-feet away from the asphalt crack (Photo 5). This cracking needs to be patched and closely monitored visually. The upstream slope on the left side of the dam (upstream of the longitudinal cracking) should be visually monitored for signs of movement or bulging. The downstream slope on the left side of the dam (downstream of the longitudinal cracking) should be cleared of vegetation obstructing visual assessment and should be closely monitored for signs of movement or bulging.

Photo 4 – Close-up of longitudinal crack on left side of dam along asphalt crest.

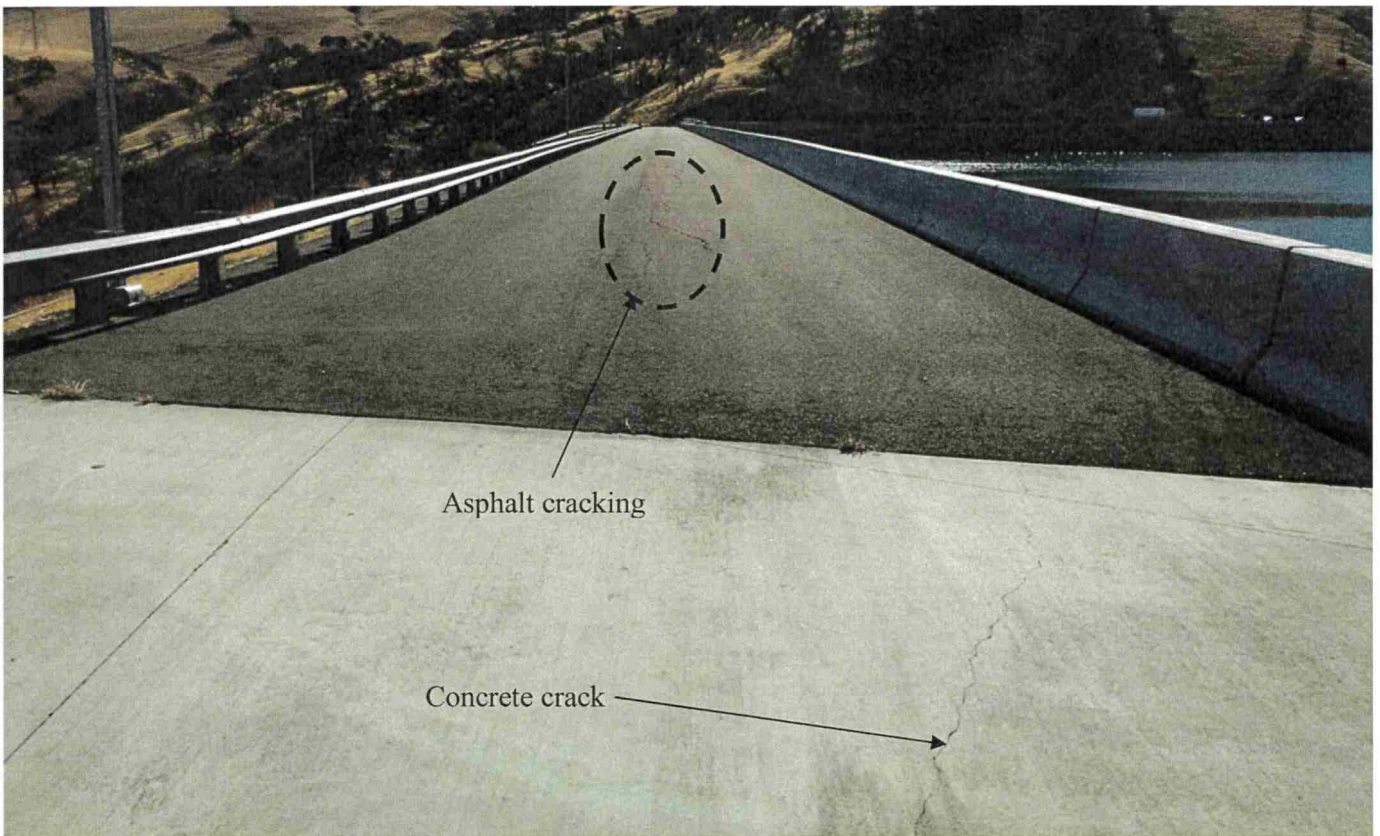
Photo 5 – View of concrete crack in the foreground and asphalt cracking in the background.

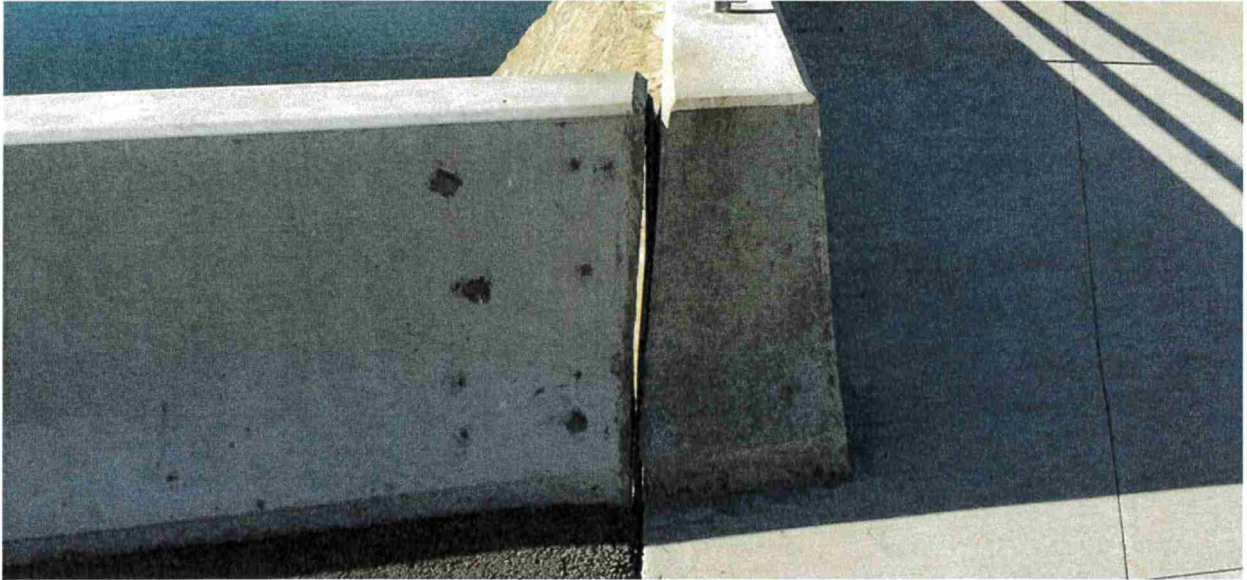
There was also a mild separation on the parapet wall where the asphalt and concrete sections meet (Photo 6). This parapet wall should also be monitored for movement. There was no visible evidence of slope movement either upstream or downstream of the crest.

Photo 6 – Separation in parapet wall where asphalt and concrete meet on dam crest.

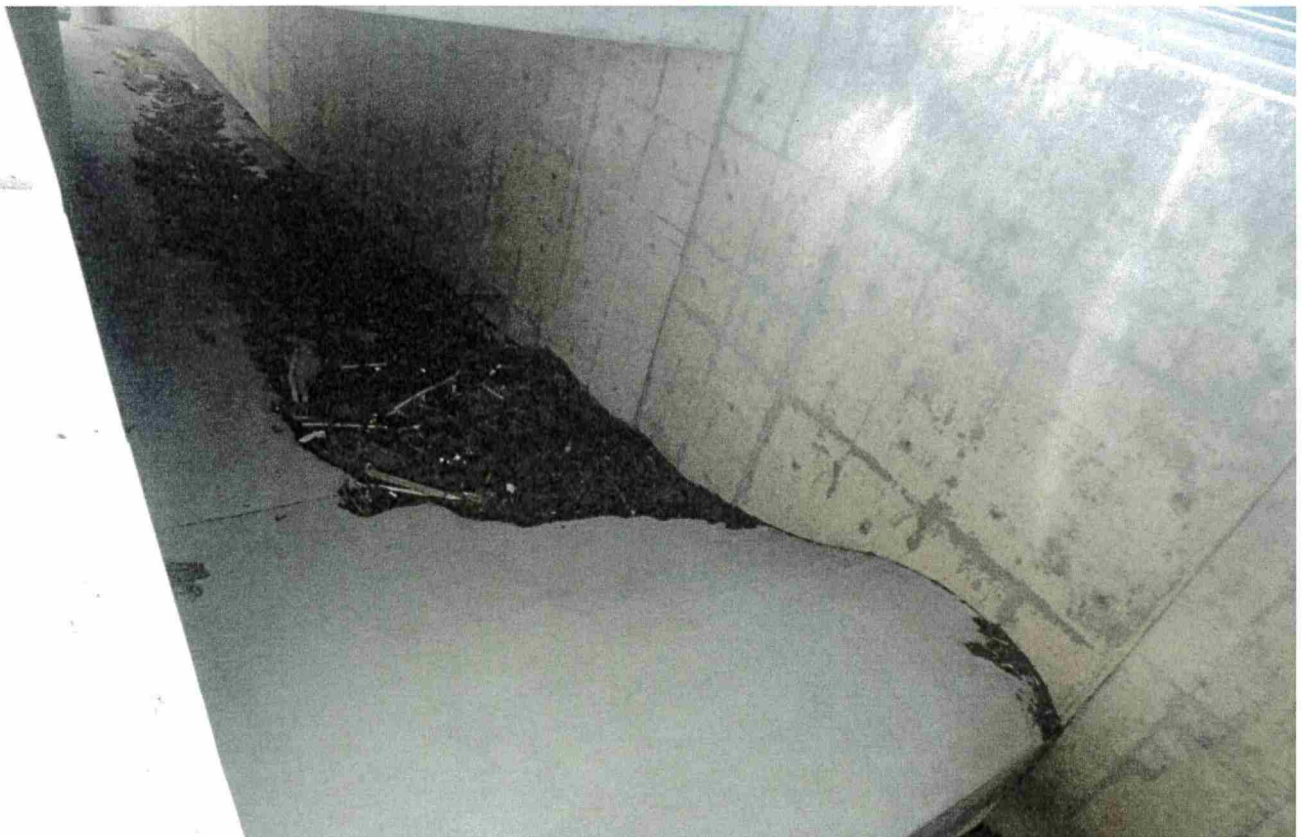
The spillway approach and ogee structure were clear and unobstructed. The upstream portion of the spillway chute contained mild debris and vegetation, which the owner needs to remove and keep clear (Photo 7). Some woody vegetation was observed adjacent to the spillway chute walls. The owner needs to remove this vegetation during regular maintenance. The stilling basin contained standing water which prevented inspection of the concrete floor and rip-rap. No apparent structural or concrete deficiencies were noted on the visible portion of the spillway structure.

Photo 7 – Debris and vegetation to be removed located at upstream portion of spillway chute.

The upstream portion of the spillway chute contained mild debris and vegetation, which the owner needs to remove and keep clear.
