June 6, 2022

Re: Arborist Pier Review Assessment of Oaks Proposed for Removal on the 5 Casa De Campo Property

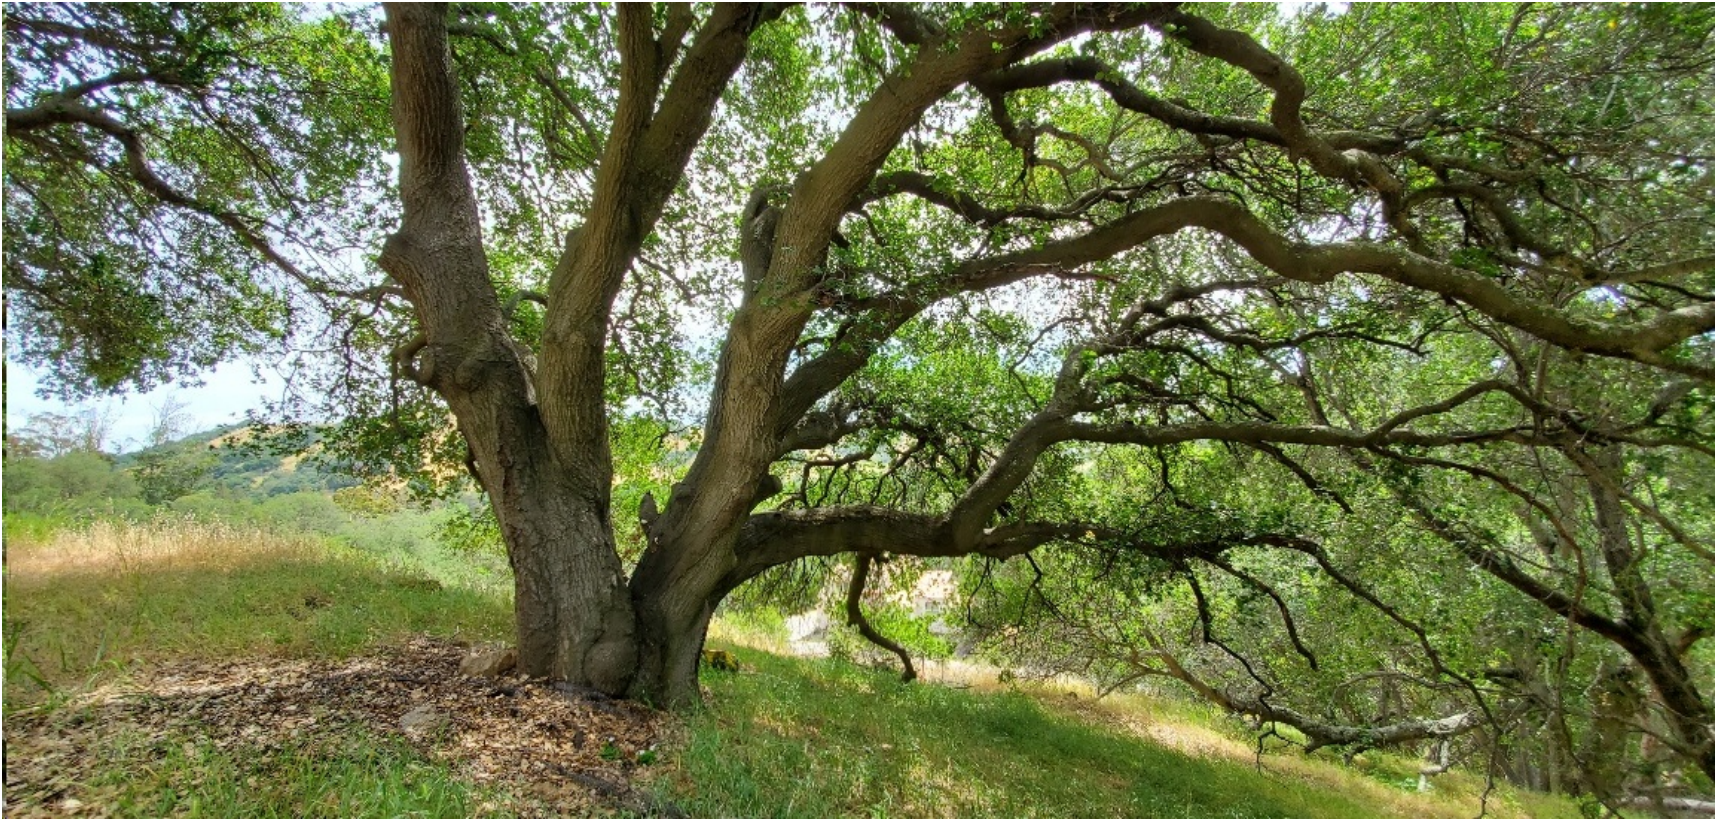
I also observed a few trees that appeared to be miss-rated or miss-identified in the report. Tree #293 listed as a 19" coast live oak in critical condition is actually a multi-stemmed tree measuring 19", 17", 15", & 12". The tree is actually one of the healthiest trees in the grove, and although it does have co-dominant leader attachments, that defect could easily be mitigated with some minor pruning and or cabling.

Tree #293 listed as being in critical condition and only 19" in diameter.

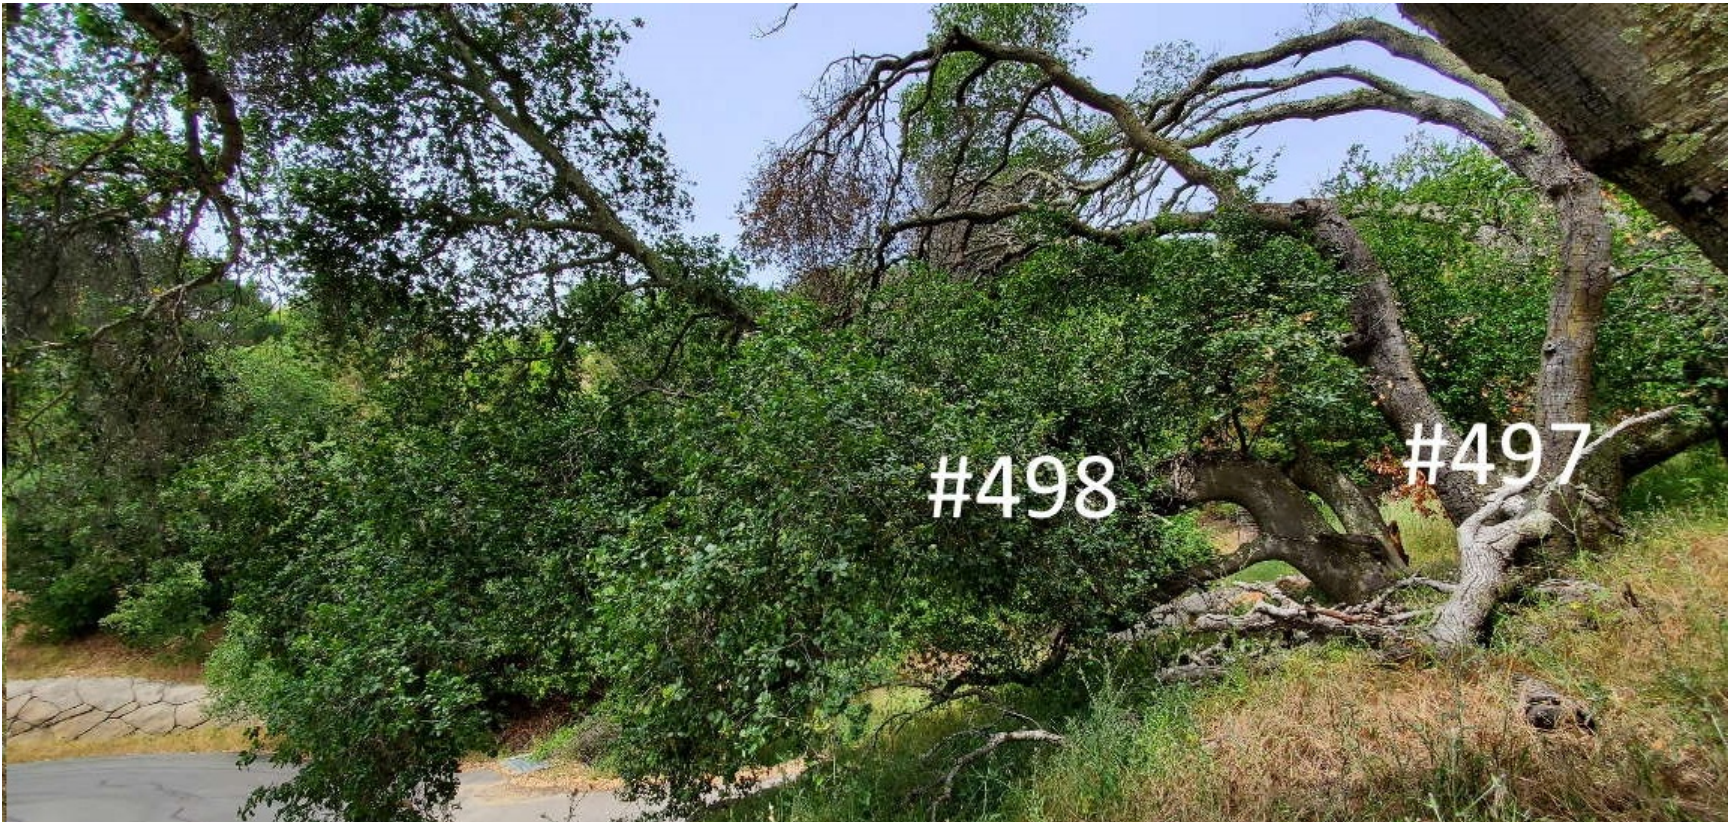
Trees #497 & 498 both listed as dead. Tree #498 is healthy with a phototropic lean that could be pruned a bit to make more pleasing and less on end weight. This tree would help with screening and erosion as well.

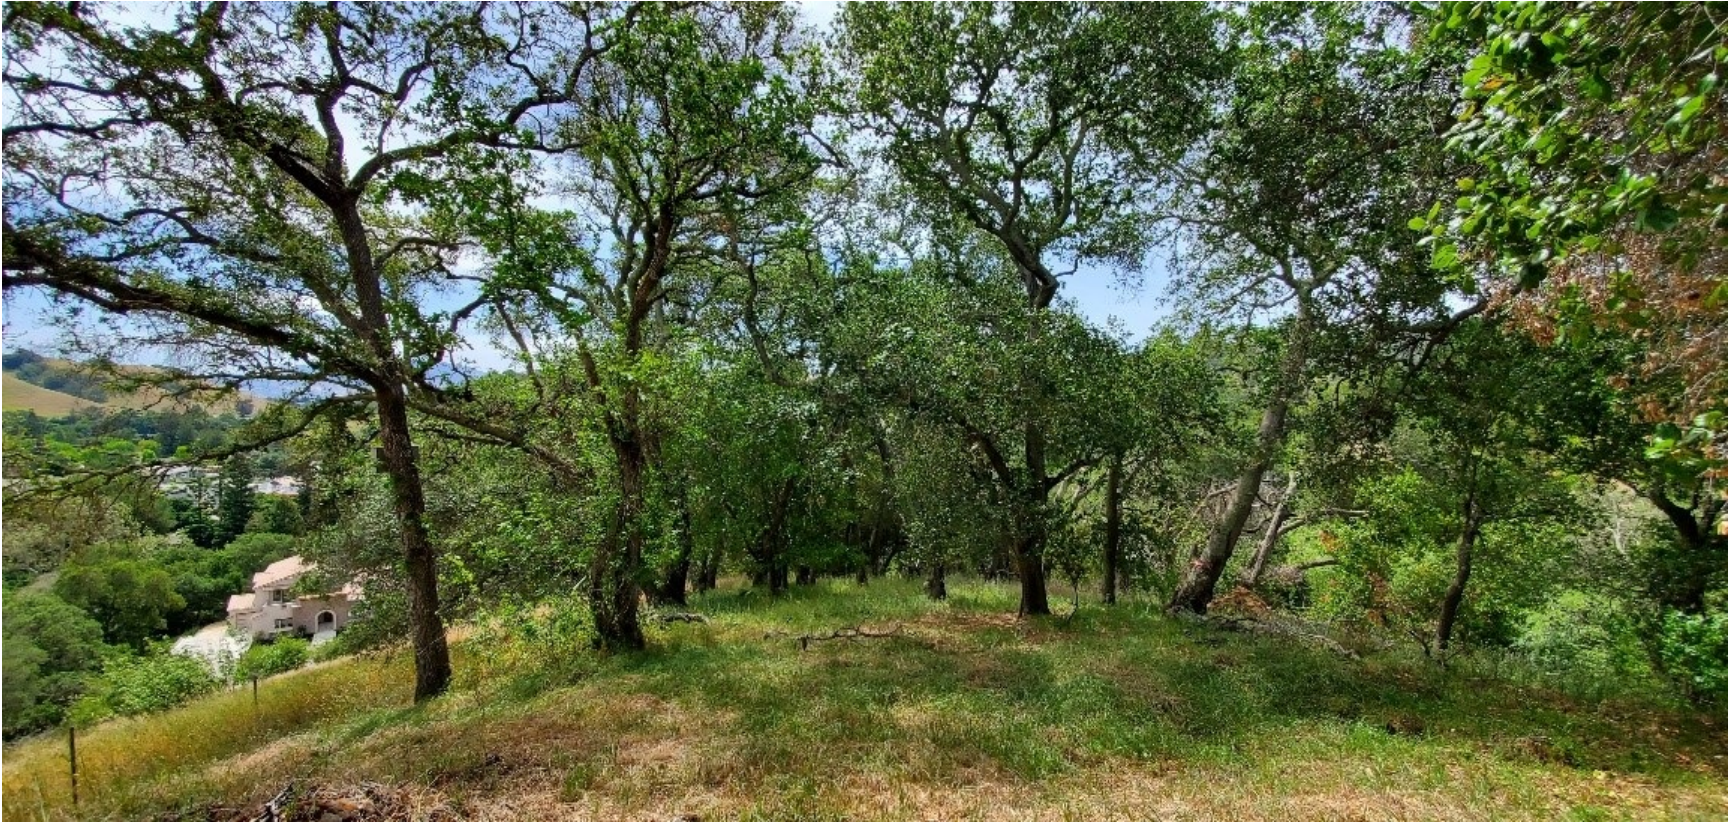
Grove of trees approved for removal. Canopies provide screening of lower home to the left from the Stokes residence up slope to the right.

I recommend reducing the total number of trees removed down to 12, consisting of the dead trees #2768, 4149, 4150, 4197, two trees leaning heavily over road (#4143 & 4147), as well as live trees # 4157, 4181, 4182, 4183, 4184, & 4185 along the east edge of the grove. The last 6 removals are to accommodate an adjusted building footprint. Limits of grading would need to be reduced as well to respect the root zones of trees to remain.
