TREE PRESERVATION REPORT

Konrad Residence Subdivision

2450 Lunada Lane

September 14, 2007

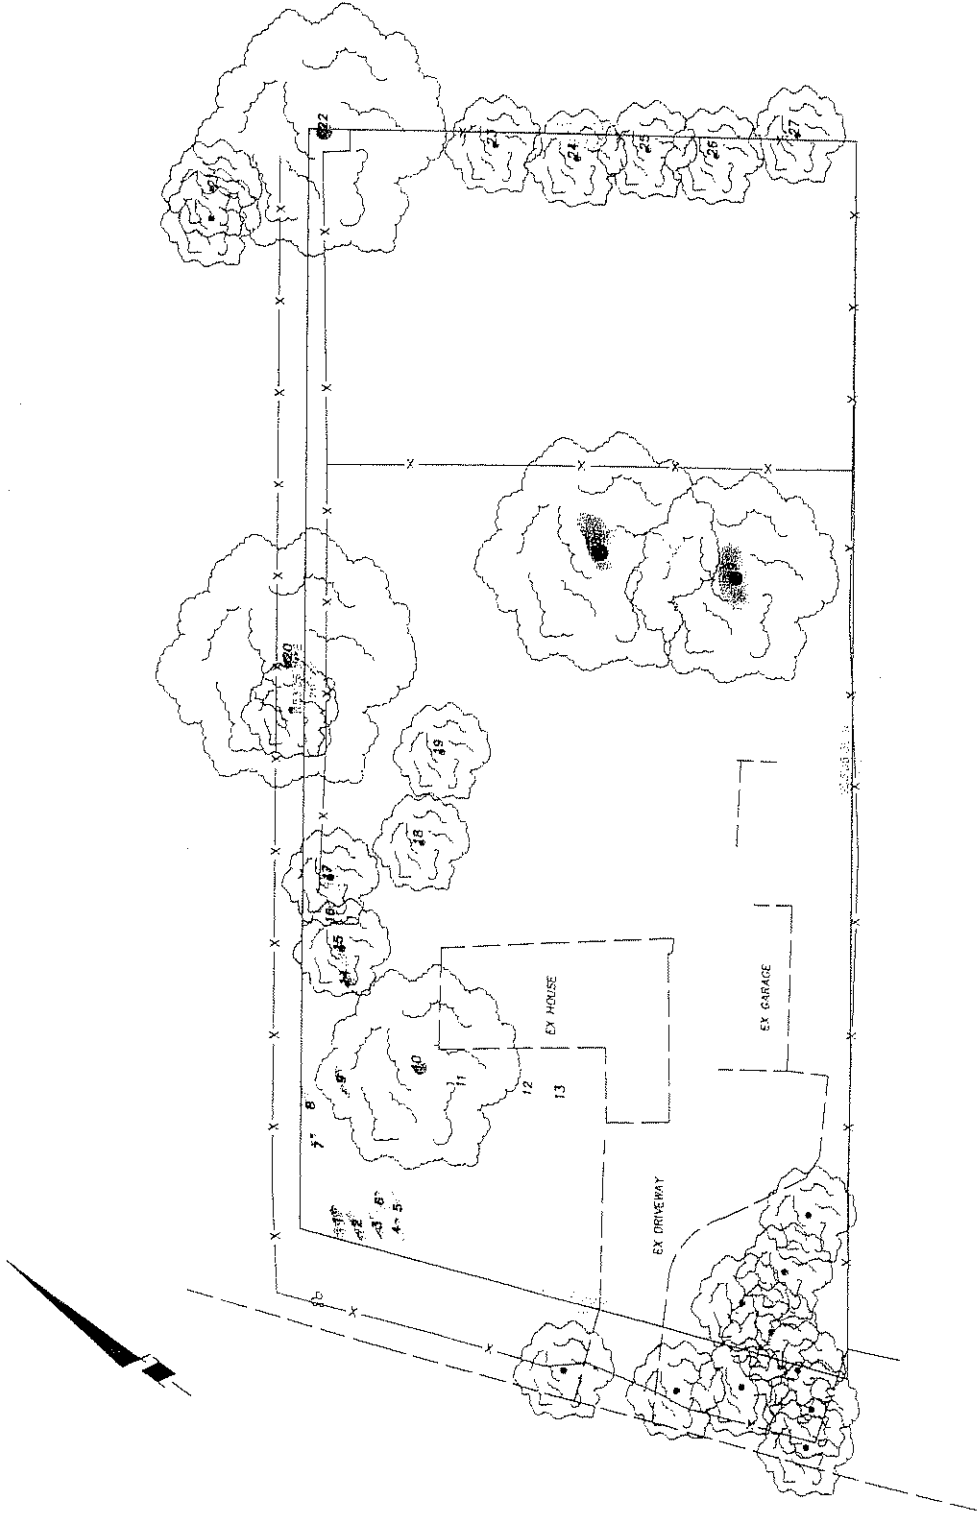
Tree Survey Map

Twenty-nine (29) trees were evaluated. Descriptions of each tree are found in the **Tree Survey** and locations are plotted on the **Tree Survey Map** (see Attachments). A summary is provided in Table 1.
