STAFF REPORT

Project Title:	Gibson Tree Permit
County File(s):	#TP17-0033
Applicant/Owner:	Gil Gibson / Same as Applicant
Appellants:	Gabriela Odell and Bruce Tarter, Sophia and Lomit Patel
Zoning/General Plan:	Single-Family Residential (R-20) / Single-Family Residential-Low Density (SL), Open Space (OS)
Site Address/Location:	1593 Hillgrade Avenue, Alamo / (APN: 188-311-011)
California Environmental Quality Act (CEQA) Status:	The project is exempt under CEQA Guidelines Section 15304, which identifies the minor alteration of land as being exempt from review.
Project Planner:	Grant Farrington, Planner I (925) 674-7797
Staff Recommendation:	Deny the Appeal and Approve the Project (See Section II for Full Recommendation)

RE.: Evaluation of trees relative to a tree permit appeal.
Contra Costa County file no.: TP17-0033.
Site: Gil Gibson, 1593 Hillgrade Ave., Alamo.

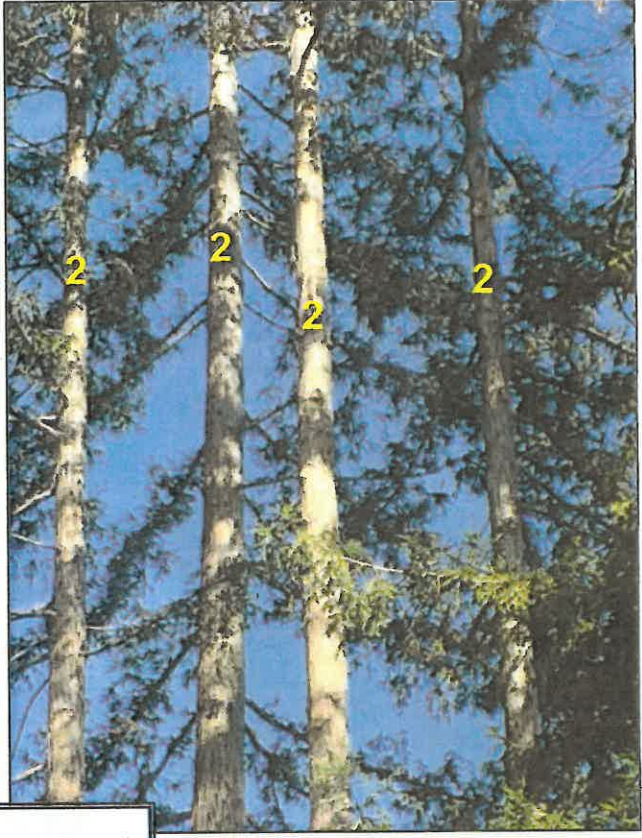
Tree no. 2:
codominant stems and
attachments.

1. Install a box cable system¹¹ between consecutive trunks; consider installation of through-bolts in the high bifurcation some years in the future.
 - a. Avoid excessive cable tension.
 - b. Anchor with drop-forged through bolts or machine-threaded through-bolts with amon nuts, appropriately sized.
 - c. ¼" EHS (extra high strength) steel cable and all hardware must be intended for arboricultural use.
2. Follow recommendations for all trees (following).

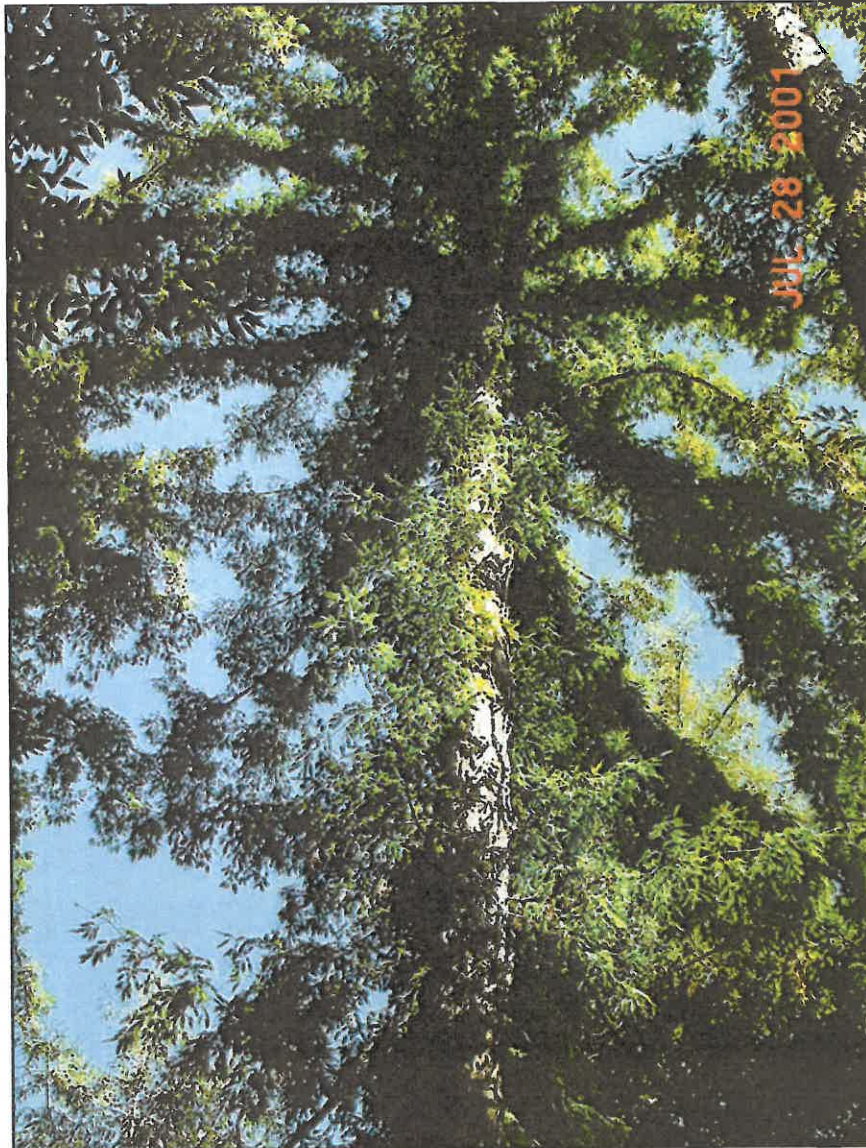
Off-site example of redwood regeneration after excessive pruning for view clearance. Note sprouting along trunk and individual limbs.

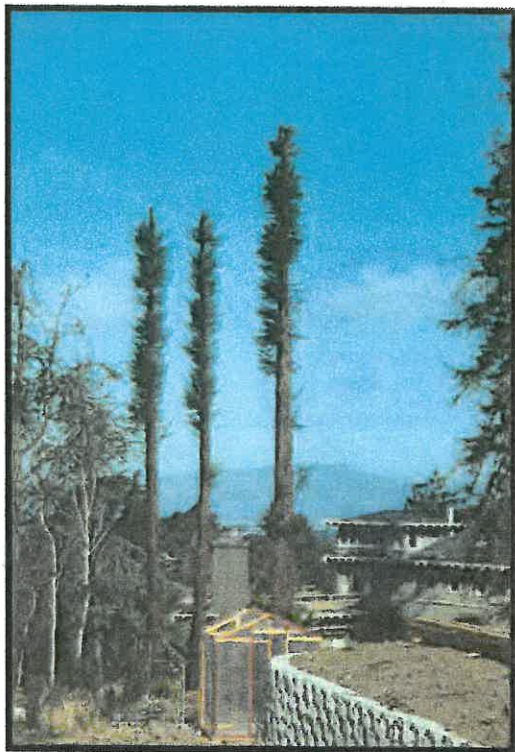
Figure 1: Redwoods after pruning of limbs and tops destroyed by fire in 1991. Photo taken August, 1992.

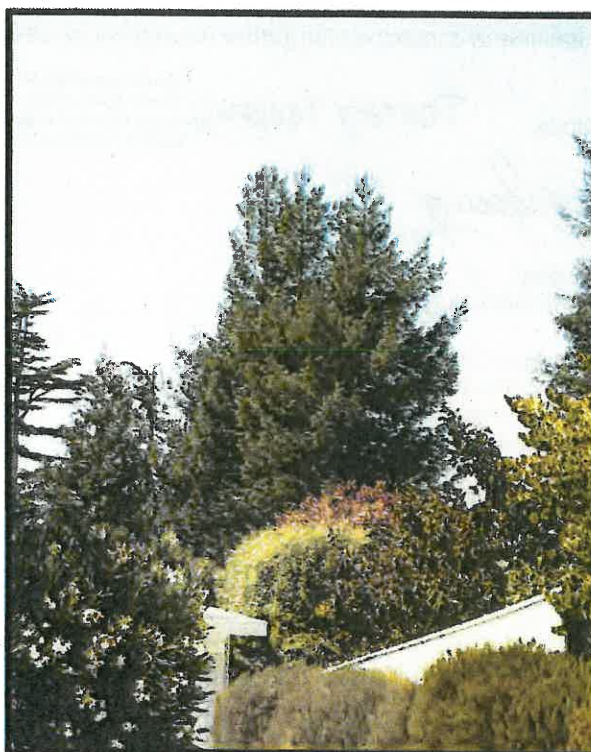
Figure 2 Same redwoods after natural regeneration and restorative pruning. Photo taken September, 2001.

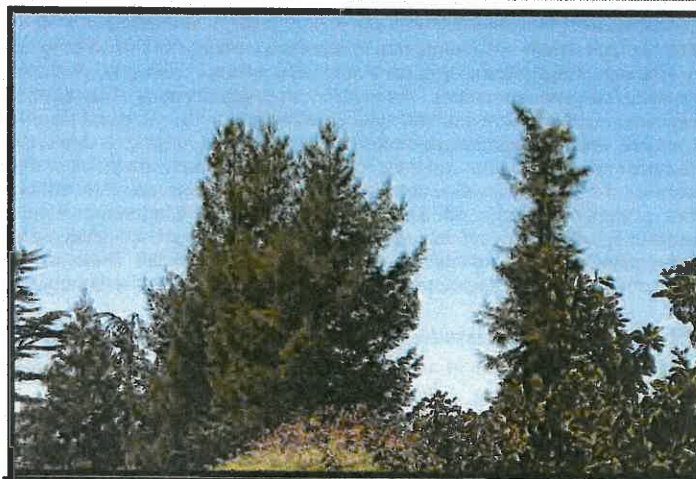
Figure 3: Same redwoods after natural regeneration and restorative pruning. Photo taken September, 2001.

Off-site example of redwood regeneration after the Oakland Firestorm of 1991. These redwoods were completely devoid of foliage and all limbs and tops were destroyed by fire. The trunks remained alive and were left to sprout naturally. Structural pruning selected permanent tops and limbs.
(Images provided by Joseph McNeil, Consulting Arborist).

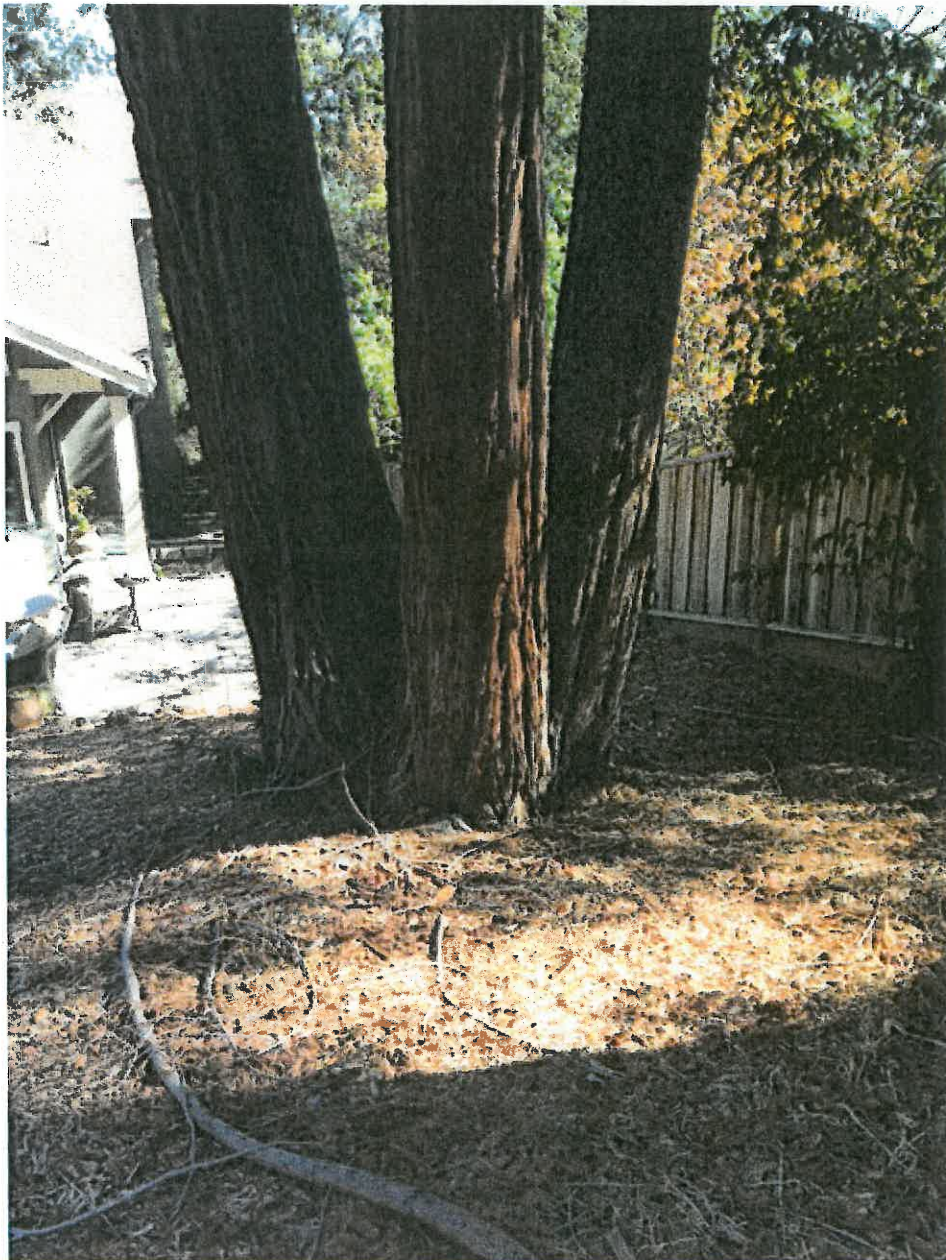
Attachment 1

The first tree I inspected is a triple leader from ground level (Attachment 1) and four leaders 20 feet up (Attachment 2). I recommend this tree be removed for safety and liability. There is no way to safely prune or remove a leader to make this tree safe. The second tree next to the fence (Attachment 3) is a large 40"Dbh., with severe decay in the canopy and several branches. The needles on this tree are also sparse throughout the canopy. The redwood tree will continue to decline and make it difficult to remove when dead. Removing the deadwood will not make the tree healthier. I recommend this tree be removed before it completely fails. The last tree is also in moderate decline with little to no new growth on the tips. This is a very sparse branch structure with poor needle growth. This tree recently had severe root damage from the new driveway and gutter right next to the root flare (Attachment 5). This is not the contributing factor to the decline but like the above factors also contributed to the decline. This tree is in decline and will eventually fail. I do recommend this tree be removed due to the location to your home and possible root excavation from the road.
