RE: County File TP17-0033  
Appeal from Panning Commission Decision dated January 24, 2017

**Appendix A – Tree and Damage Images Taken**

# Dryad, LLC

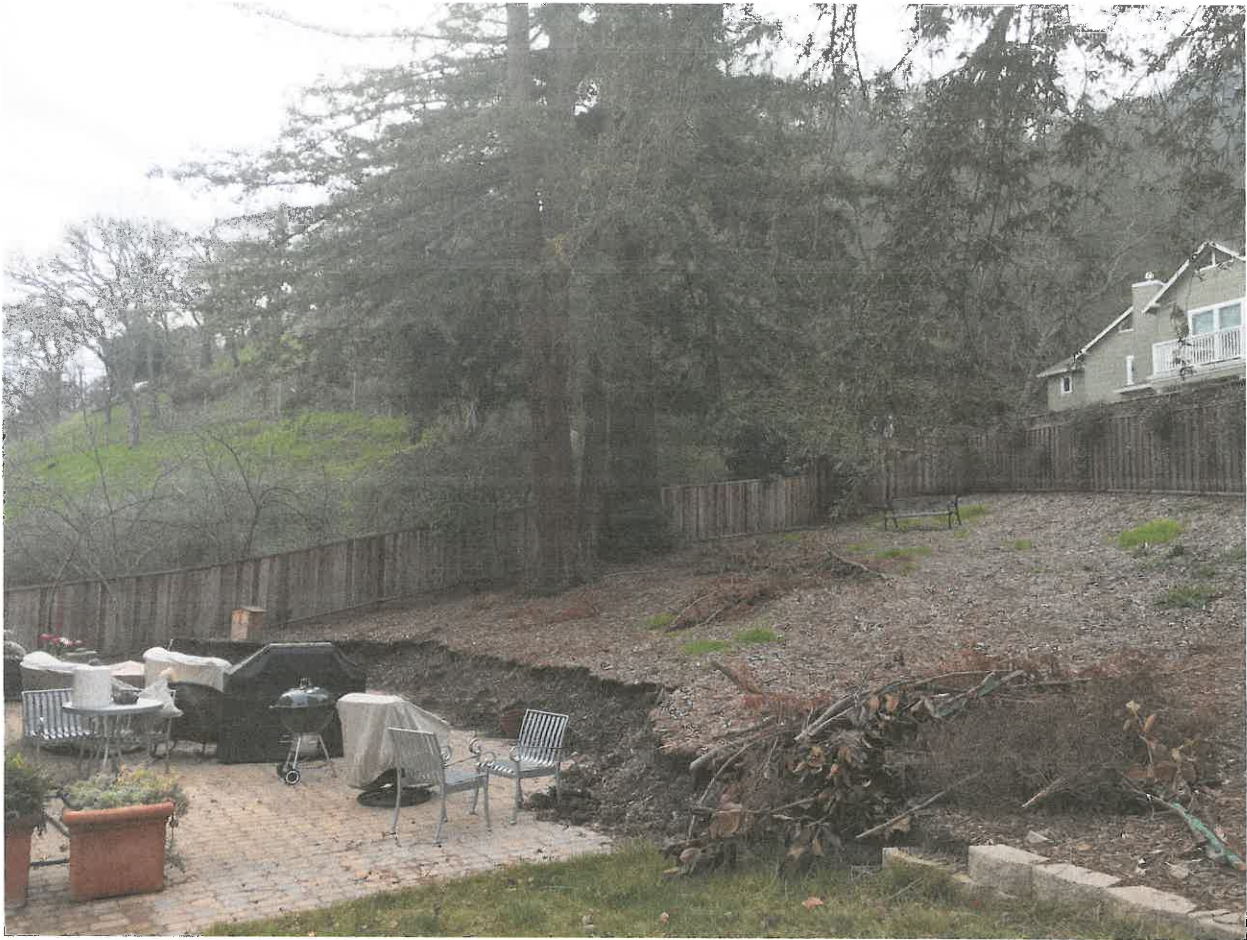
**Photo 1**

This image, taken by me on 1/29/18 from the street shows the construction damage done to the roots of the redwood trees at 1593 Hillgrade Ave. The owners of this property clearly didn't follow the recommendations of the Warner Tree Experts Report, written for the development of this property in 2014. Masses of cut roots are visible at the base of the slope, particularly toward the bottom right of the image. In spite of this damage, however, the trees will recover if the recommendations in the Torrey Young report and this one are followed.

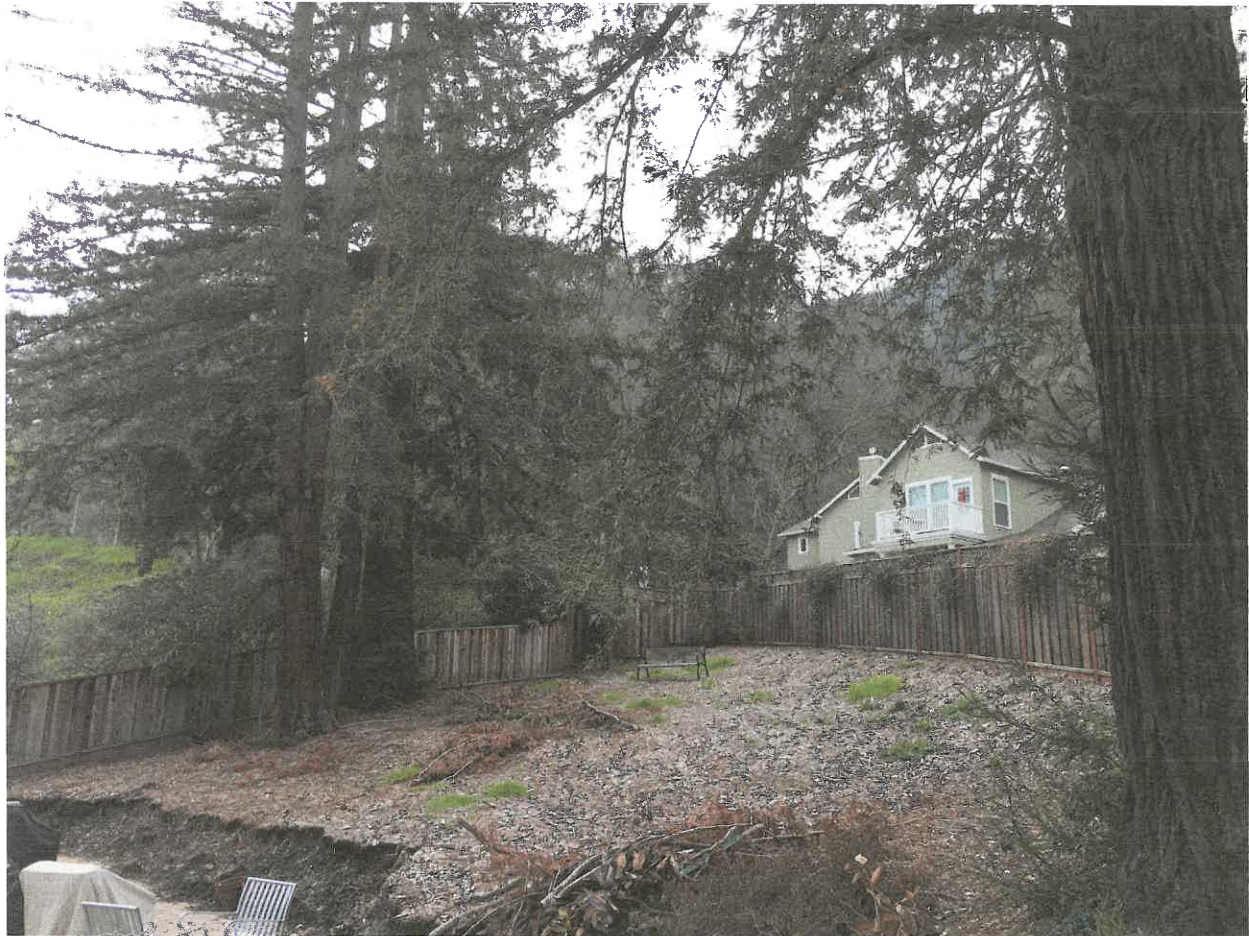
**Photo 2**

This image, taken by me on 1/29/18 from the street at 1593 Hillgrade Ave, shows all of the trees, most of the construction damage done to the roots of the redwood trees, the regeneration of new offsets at the base of the tree trunks, and the new growth on the lower branches of these trees. The large trees, or the first growth trunks, are putting on new growth from both the trunks and the branches. And even if the large trees are cut down, which I don't recommend, the new offset trees growing at the base of the trunk will replace whatever is lost as secondary growth.

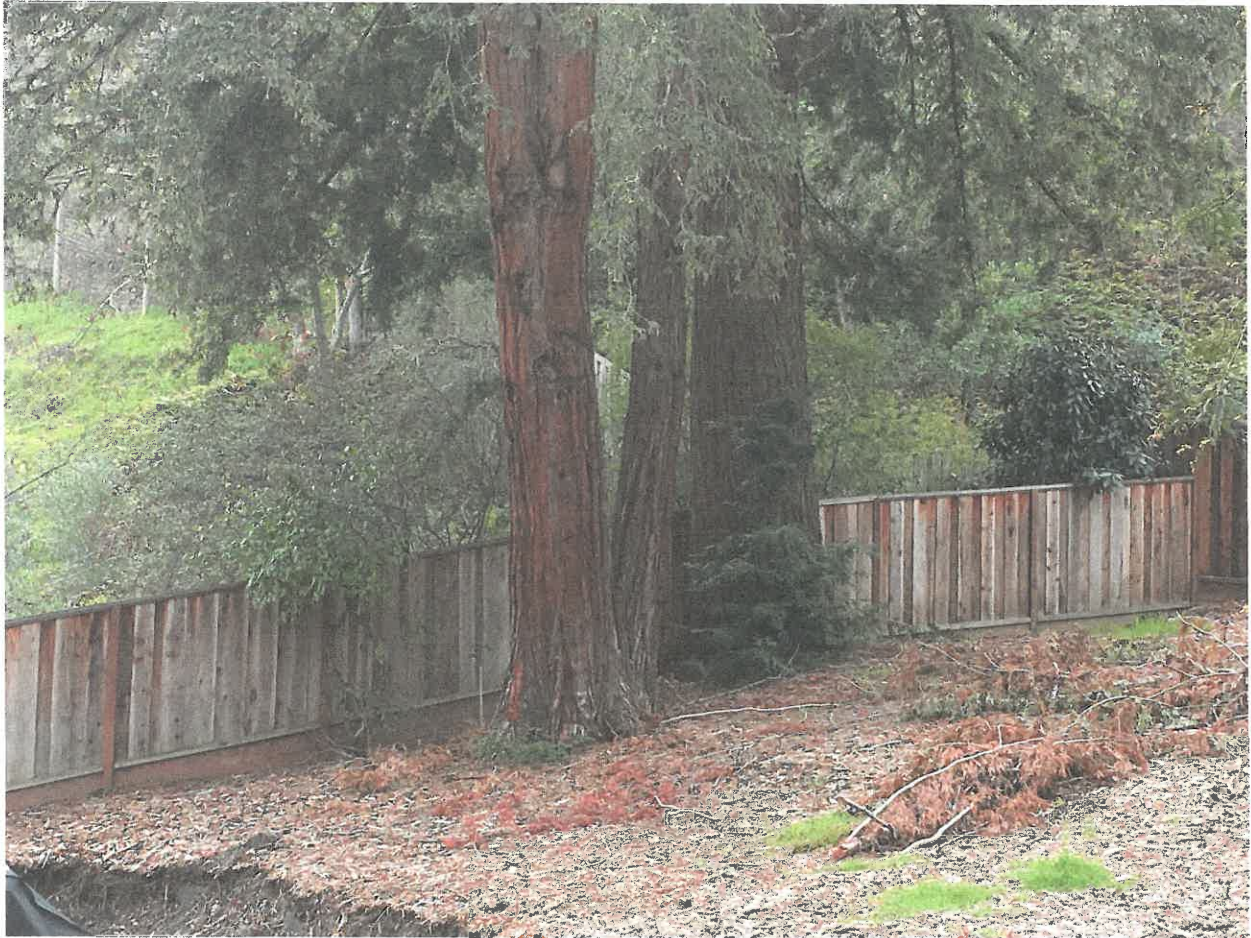
**Photo 3**

This image, taken by me on 1/29/18 from the street, shows some of the construction damage done to the roots of the redwood trees farthest from the street at 1593 Hillgrade Ave, along with some dead branches. However, the trunks of these trees appear healthy; and the new offset trees at the base of the plants clearly illustrate the recuperative capacity of coast redwoods. New growth is also visible on the lower branches of these trees. Even if the large trees were cut down, which I don't recommend, the new offset trees growing at the base of the trunk will replace whatever is lost.

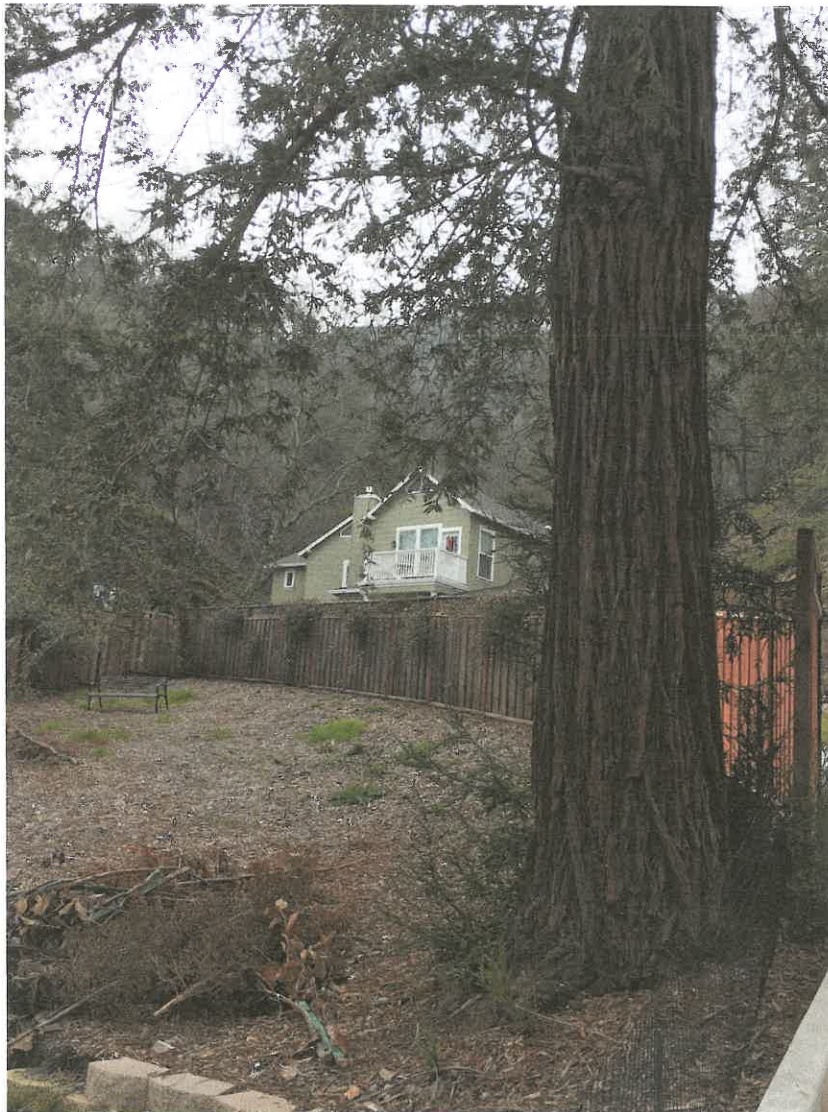
**Photo 4**

This image, taken by me on 1/29/18 from the street, shows the construction damage done to the roots of the redwood tree closest to the street at 1593 Hillgrade Ave. The trunk of the tree appears healthy; and the new offset trees at the base of the plant clearly illustrate the recuperative capacity of coast redwoods. New growth is also visible on the lower branches of this tree. This image also illustrates the vast network of redwood roots in the soil that are receiving water from the canyon above.

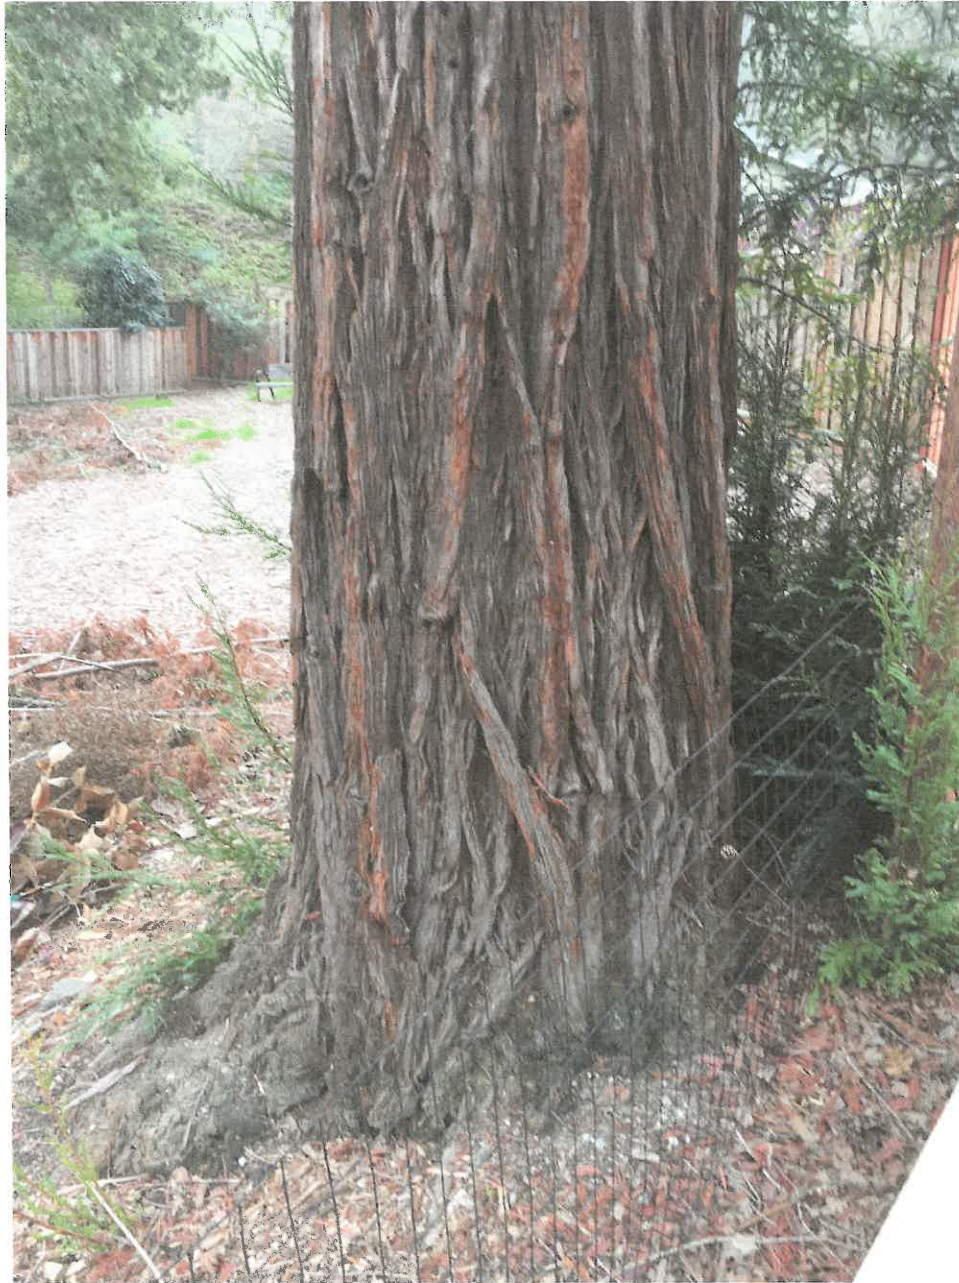
**Photo 5**

This image, taken by me on 1/29/18 from the street at 1593 Hillgrade Ave, is a closeup of the base of the trunk of the redwood closest to the street, with many new offset trees growing at the base of the trunk. Both offsets and epicormic shoots from the branches and trunks will replace whatever growth has been lost.

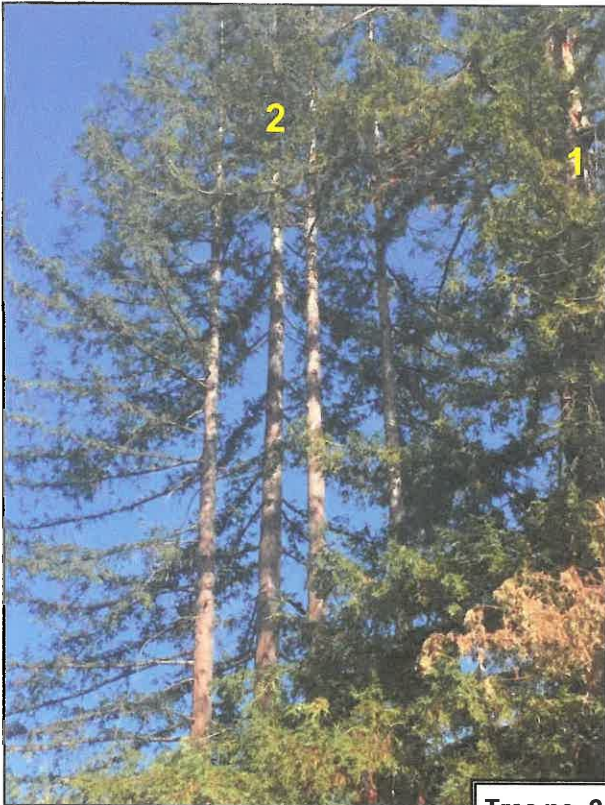
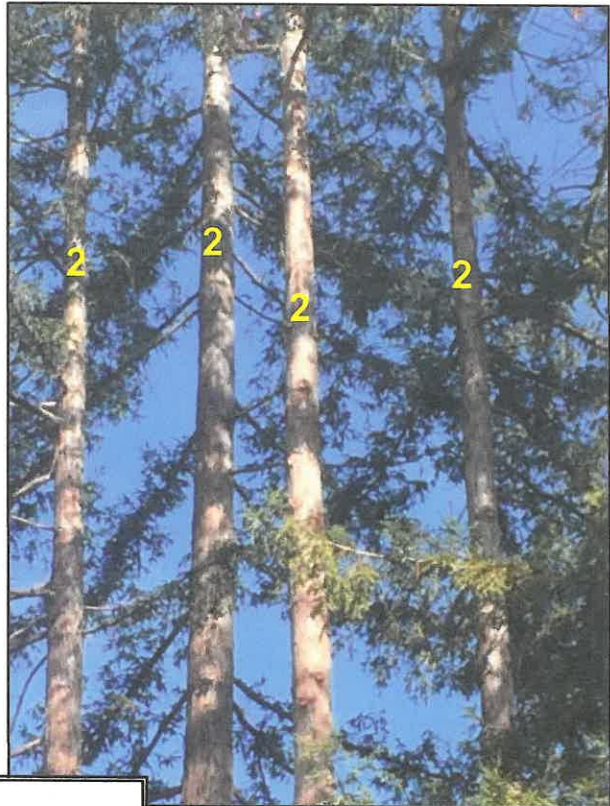
**Tree no. 2:**  
codominant stems and  
attachments.

1. Install a box cable system<sup>11</sup> between consecutive trunks; consider installation of through-bolts in the high bifurcation some years in the future.
  - a. Avoid excessive cable tension.
  - b. Anchor with drop-forged through bolts or machine-threaded through-bolts with amon nuts, appropriately sized.
  - c. ¼" EHS (extra high strength) steel cable and all hardware must be intended for arboricultural use.
2. Follow recommendations for all trees (following).
