Re: Driveway widening for 0 West Newell Avenue, Walnut Creek

Arborist Report Addendum

TP19-0036

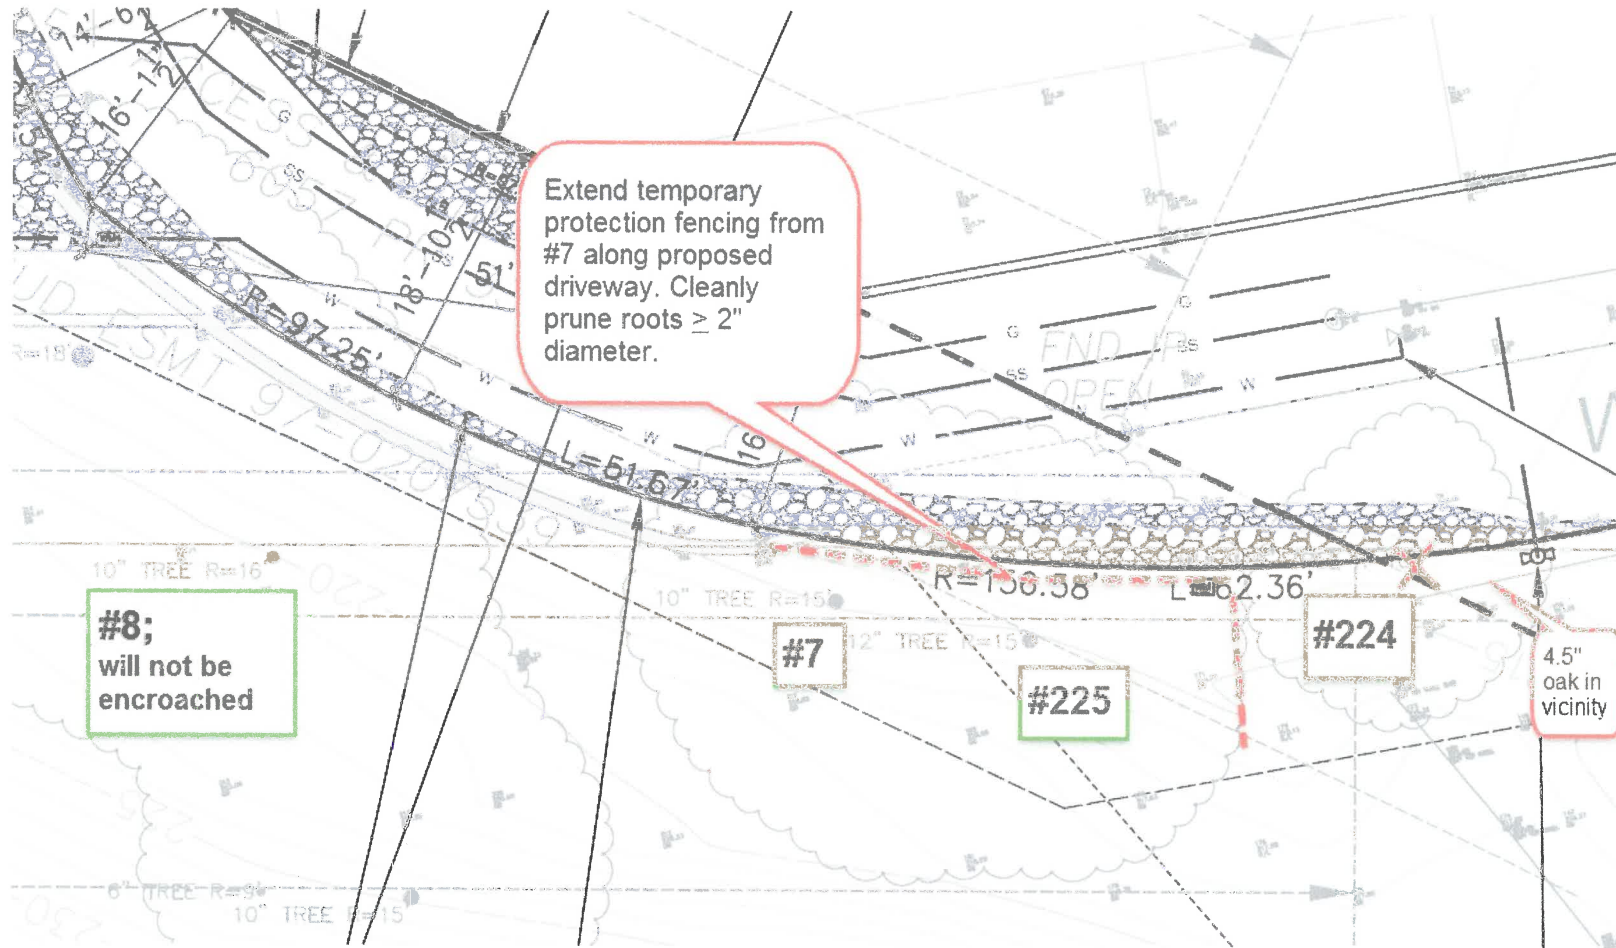
The road will be widened at the east end of the property, which occurs near tree #8 and two additional oaks (#224, 225). The tree protection recommendations from my 7/3/19 arborist report are still valid for trees #7 & 8. Root encroachment is acceptable for tree #225, but high for #224 since the driveway terminates 1' from the trunk.

Figure 1. Most recent plan showing new driveway, with updates to tree protection recommendations.

- Remove tree #224.
- Prior to construction or grading, contractor shall install temporary fencing along the proposed driveway to construct a temporary Tree Protection Zone (TPZ) around the trees that will be retained. Heavy duty orange poly fencing may be used if it is securely attached to metal stakes spaced 6' apart. (change from previous report which specifically requested chain-link)
- If roots $\geq 2"$ diameter are encountered during excavation by trees #225, they shall be cleanly pruned, covered, and kept moist till backfilled.
