STAFF REPORT

Project Title:	Gibson Tree Permit
County File(s):	#TP17-0033
Applicant/Owner:	Gil Gibson / Same as Applicant
Appellants:	Gabriela Odell and Bruce Tarter, Sophia and Lomit Patel
Zoning/General Plan:	Single-Family Residential (R-20) / Single-Family Residential-Low Density (SL), Open Space (OS)
Site Address/Location:	1593 Hillgrade Avenue, Alamo / (APN: 188-311-011)
California Environmental Quality Act (CEQA) Status:	The project is exempt under CEQA Guidelines Section 15304, which identifies the minor alteration of land as being exempt from review.
Project Planner:	Grant Farrington, Planner I (925) 674-7797
Staff Recommendation:	Deny the Appeal and Approve the Project (See Section II for Full Recommendation)

RE.: Evaluation of trees relative to a tree permit appeal.
Contra Costa County file no.: TP17-0033.
Site: Gil Gibson, 1593 Hillgrade Ave., Alamo.

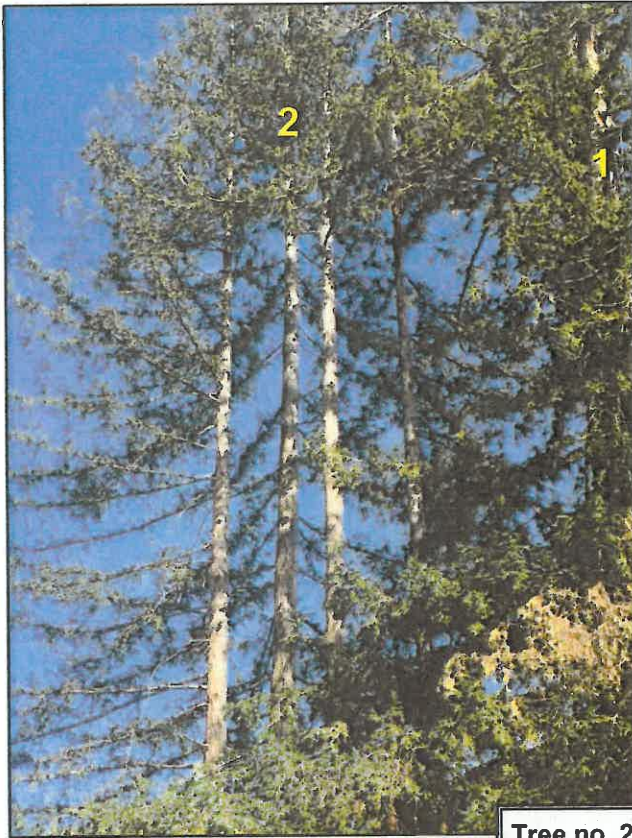
Tree no. 2:
codominant stems and
attachments.

1. Install a box cable system¹¹ between consecutive trunks; consider installation of through-bolts in the high bifurcation some years in the future.
 - a. Avoid excessive cable tension.
 - b. Anchor with drop-forged through bolts or machine-threaded through-bolts with amon nuts, appropriately sized.
 - c. ¼" EHS (extra high strength) steel cable and all hardware must be intended for arboricultural use.
2. Follow recommendations for all trees (following).
