RE: County File TP17-0033  
Appeal from Panning Commission Decision dated January 24, 2017

**Appendix A – Tree and Damage Images Taken**

# Dryad, LLC

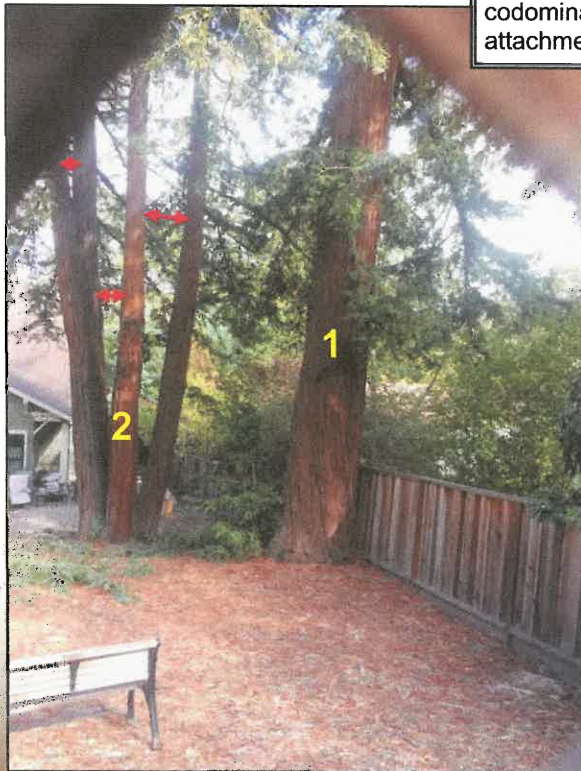
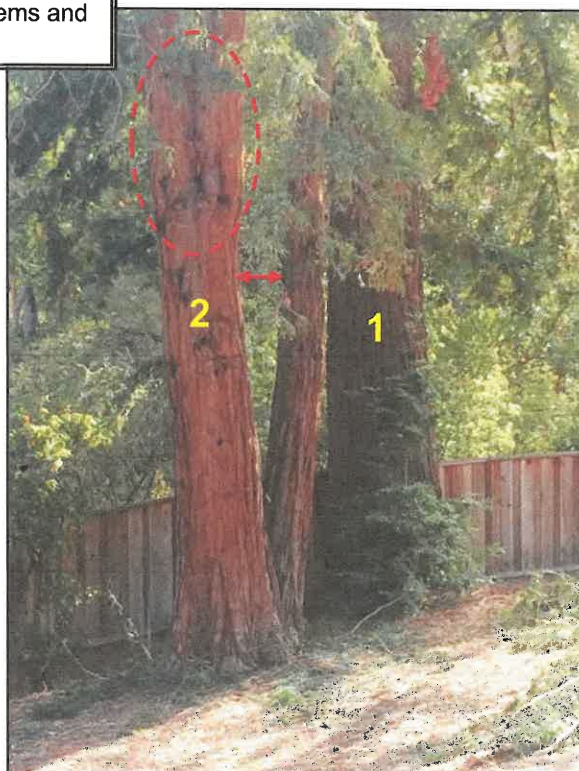
**Tree no. 2:**  
codominant stems and  
attachments.

1. Install a box cable system<sup>11</sup> between consecutive trunks; consider installation of through-bolts in the high bifurcation some years in the future.
  - a. Avoid excessive cable tension.
  - b. Anchor with drop-forged through bolts or machine-threaded through-bolts with amon nuts, appropriately sized.
  - c. ¼" EHS (extra high strength) steel cable and all hardware must be intended for arboricultural use.
2. Follow recommendations for all trees (following).

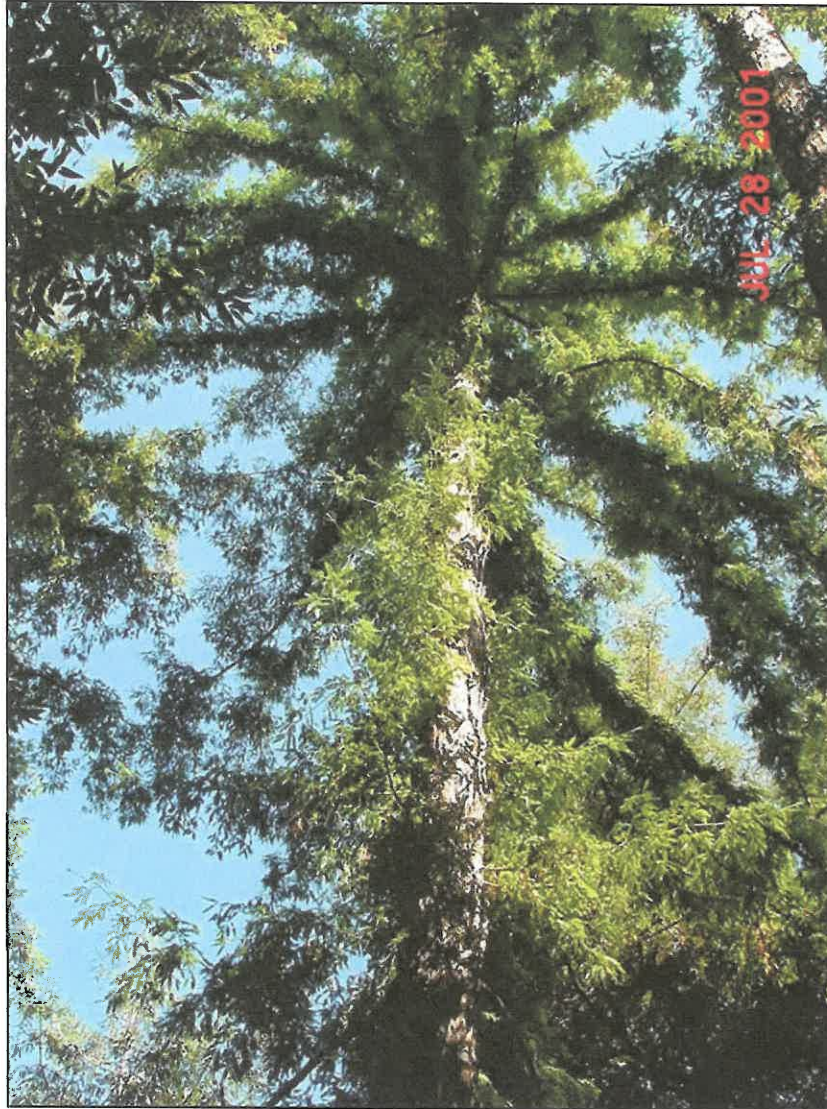
Off-site example of redwood regeneration after excessive pruning for view clearance. Note sprouting along trunk and individual limbs.

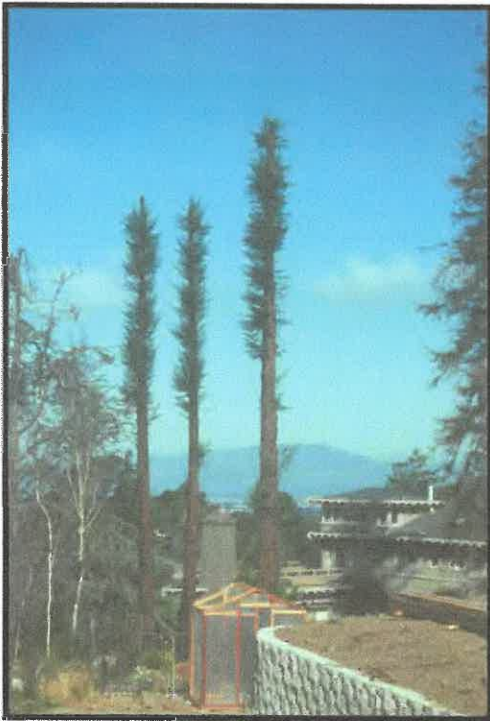
**Figure 1:** Redwoods after pruning of limbs and tops destroyed by fire in 1991. Photo taken August, 1992.

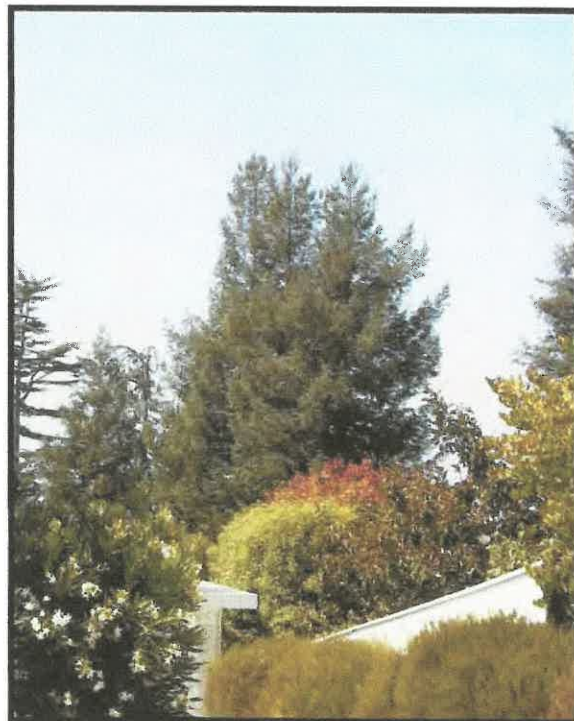
**Figure 2** Same redwoods after natural regeneration and restorative pruning. Photo taken September, 2001.

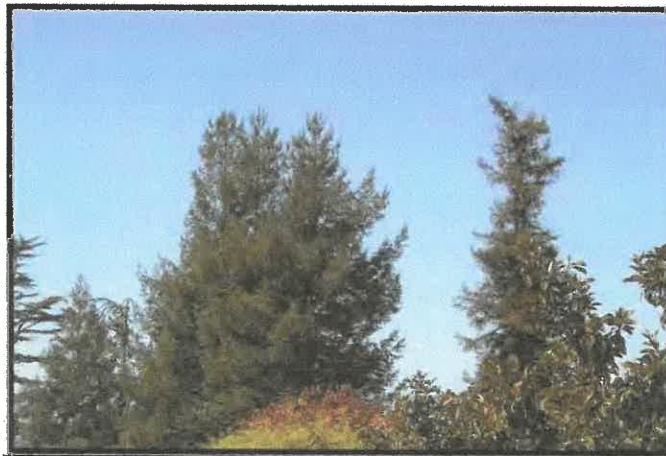
**Figure 3:** Same redwoods after natural regeneration and restorative pruning. Photo taken September, 2001.

Off-site example of redwood regeneration after the Oakland Firestorm of 1991. These redwoods were completely devoid of foliage and all limbs and tops were destroyed by fire. The trunks remained alive and were left to sprout naturally. Structural pruning selected permanent tops and limbs.  
(Images provided by Joseph McNeil, Consulting Arborist).
