WIEDEMANN RANCH GEOLOGIC HAZARD  
ABATEMENT DISTRICT (GHAD)

PLAN OF CONTROL  
PODVA PROPERTY DEVELOPMENT ANNEXATION

Prepared by  
ENGEO Incorporated

June 18, 2015  
Revised January 7, 2016

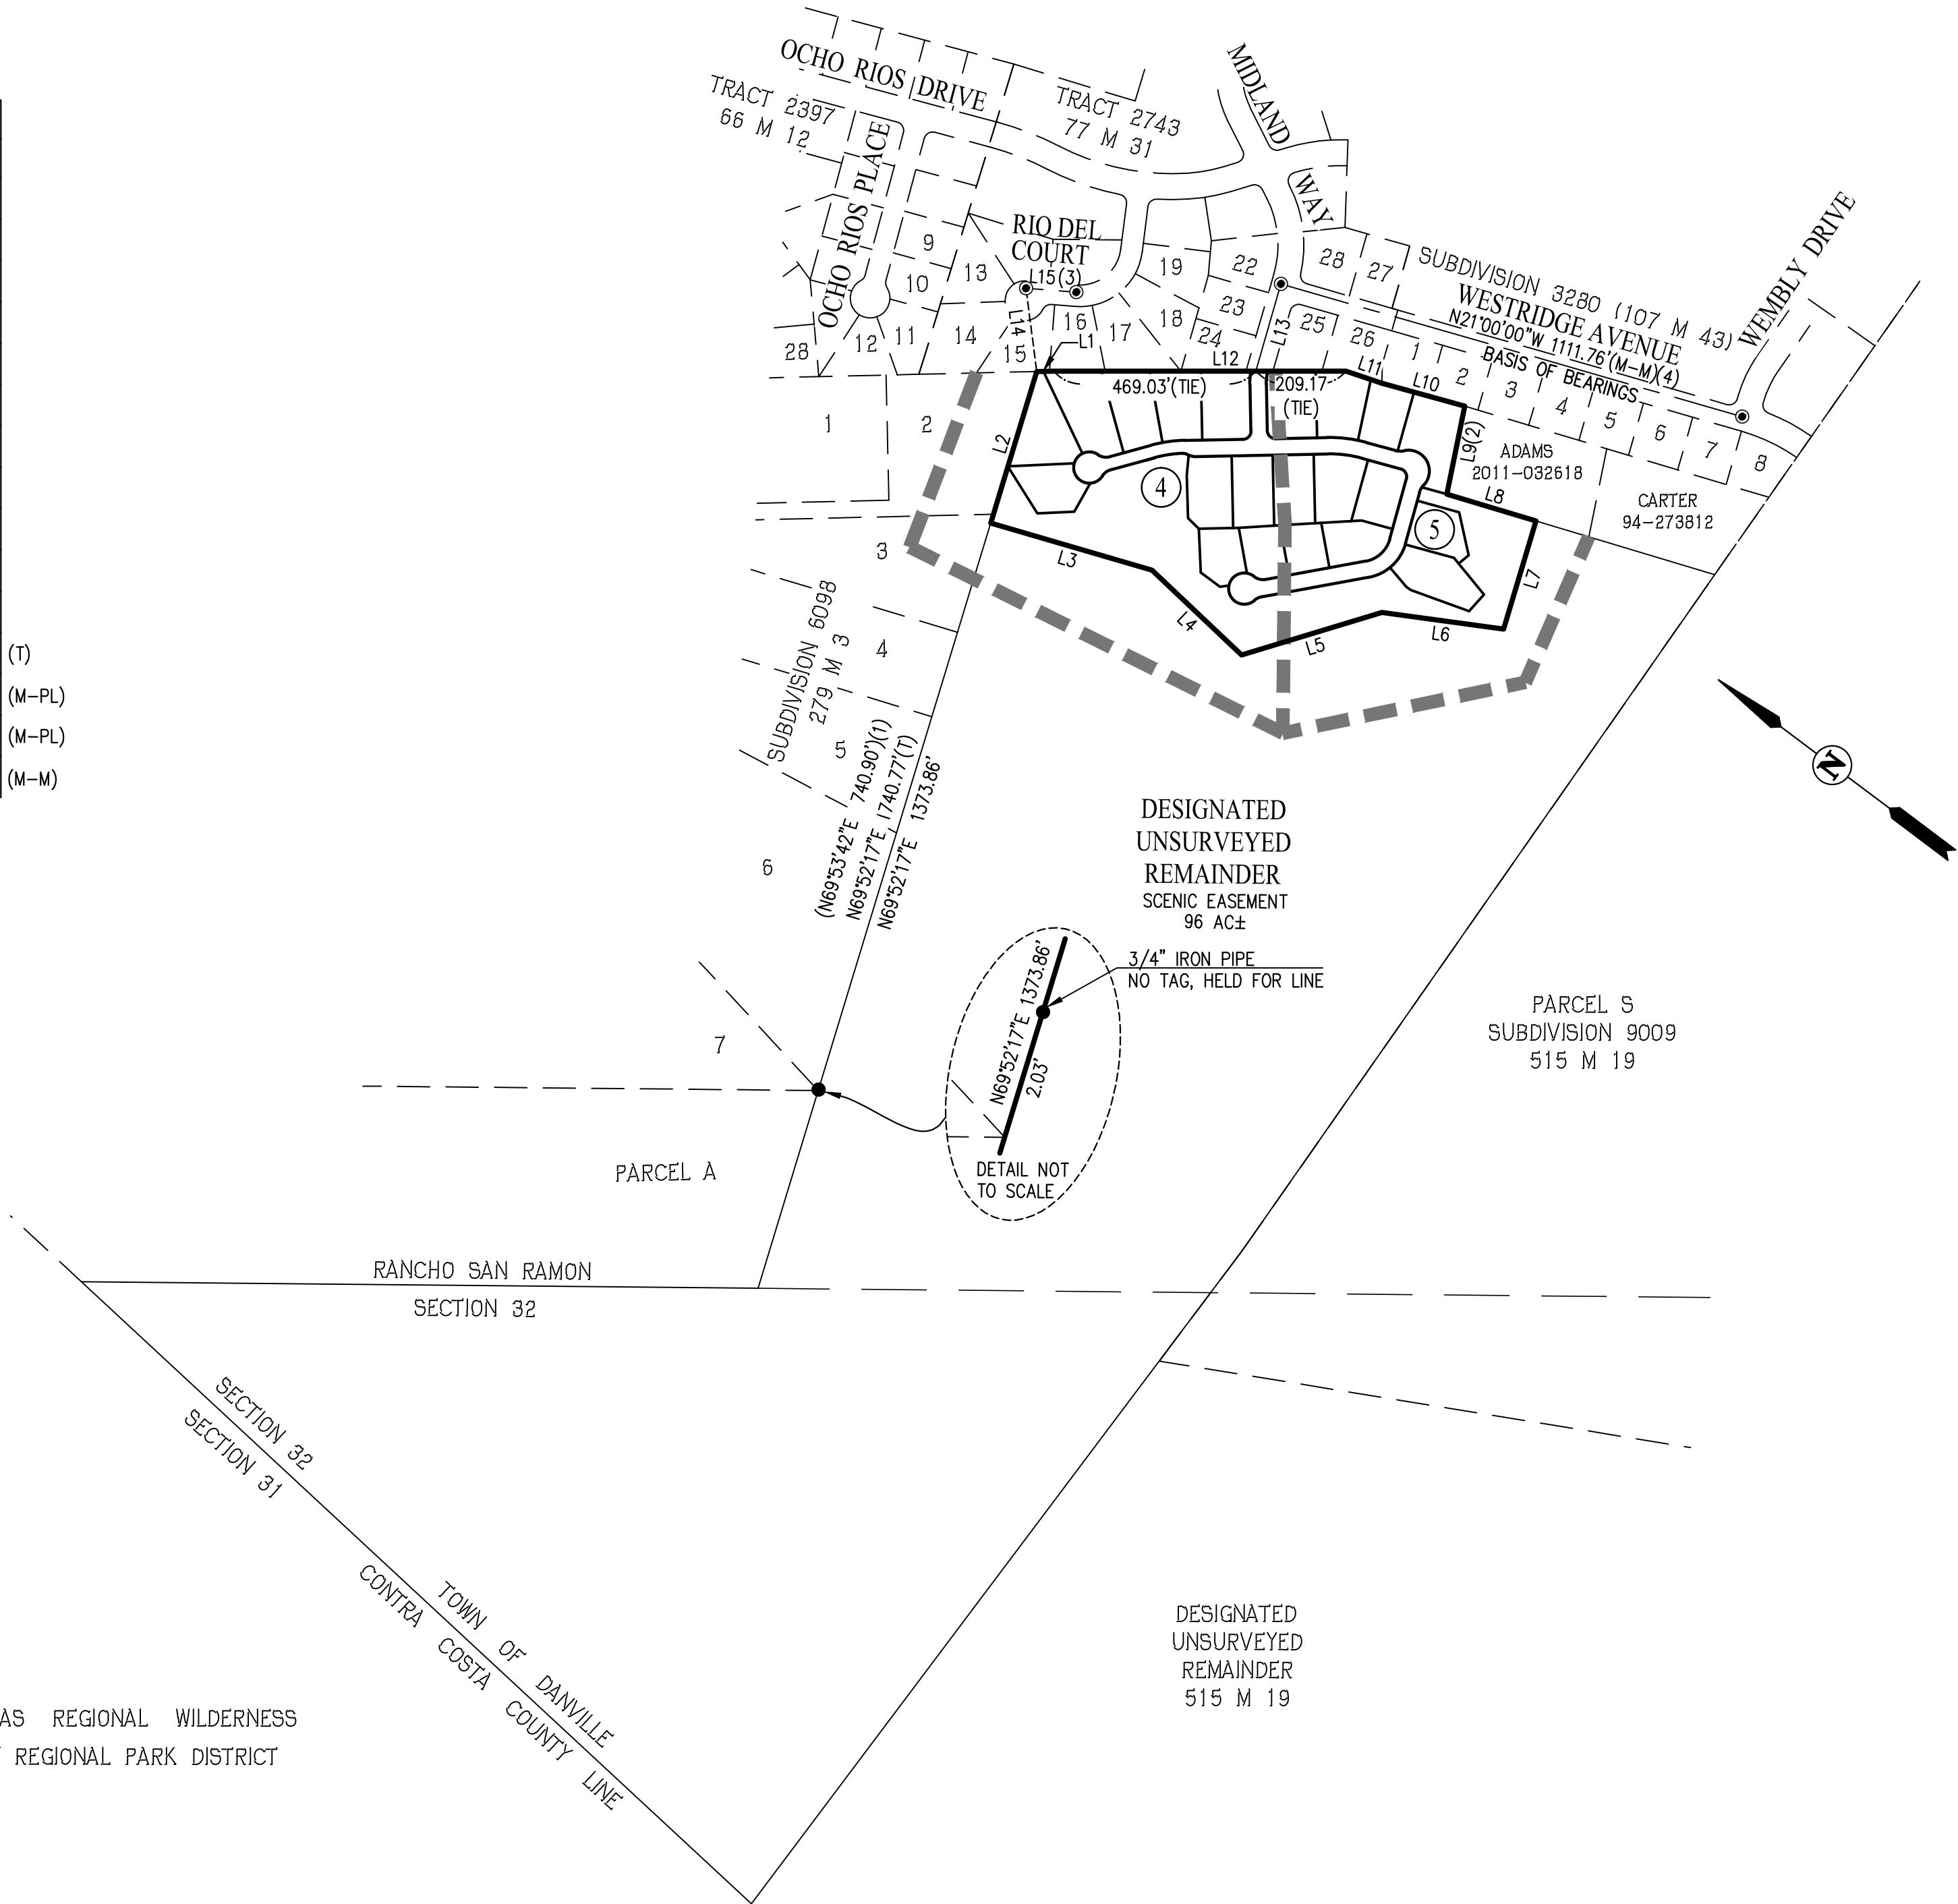
THE BASIS OF BEARINGS FOR THIS SURVEY IS DETERMINED BY FOUND MONUMENTS SHOWN ON WESTRIDGE AVENUE, THE BEARING BEING N21°00'00"W PER TRACT NO. 3280 (107 M 43).

SUBDIVISION BOUNDARY LINE
	RIGHT OF WAY LINE
	LOT LINE
	EASEMENT LINE
	MONUMENT LINE
	ADJOINER LINE
	RANCHO AND SECTION LINE
(T)	TOTAL
(R)	RADIAL
(M-M)	MONUMENT TO MONUMENT
(M-PL)	MONUMENT TO PROPERTY LINE
⊙	FOUND STANDARD STREET MONUMENT
⊙	SET STANDARD STREET MONUMENT
●	FOUND MONUMENT AS NOTED
LME	LANDSCAPE MAINTENANCE EASEMENT
PUE	PUBLIC UTILITY EASEMENT
TMAE	TRAIL MAINTENANCE ACCESS EASEMENT
	SHEET LIMIT
2	SHEET NUMBER
