To: The Contra Costa Supervisors Transportation, Water & Infrastructure Committee (TWIC)

From: Jonathan Goodwin & Sveinn Erik Ólafsson (Canyon residents)

Re: Report on Needed Capital Improvements to Pinehurst Road in District 2

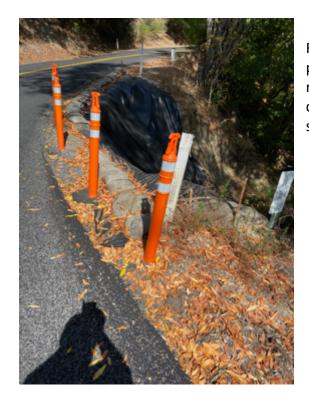
Repair Location 1 - On Pinehurst Road near postmile 0.2 there is a culvert washout needing repair with possibly a gabion wall, or interlocking concrete bars or some other form of structural support and possible culvert replacement.

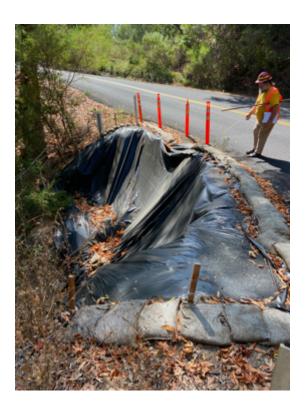
Repair Location 2 – postmile 1.7 two washouts in close proximity, one with black plastic, and one without. The one without black plastic is the site of a fatal accident on December 28, 2009 when a Canyon resident drove into the creek at this site. These sites would benefit from a gabion basket wall or interlocking concrete bars. a culvert replacement and perhaps a guardrail.

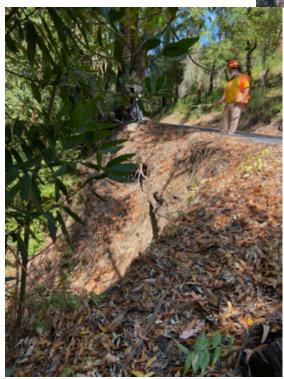
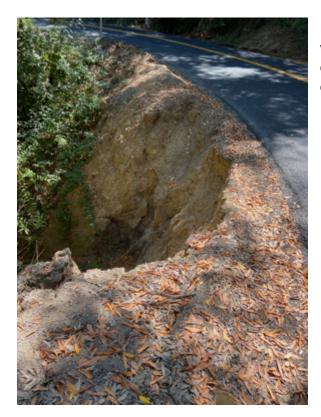
Repair Location 3 – postmile 4.6-4.7. Culvert washout undermining road. Replace culvert and establish erosion control such as gabion baskets or interlocking concrete bars, and guardrail.

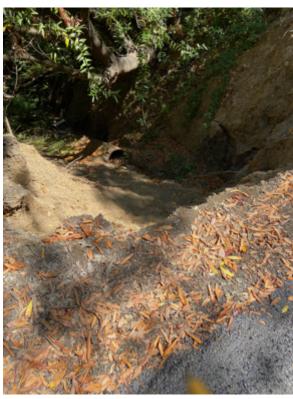
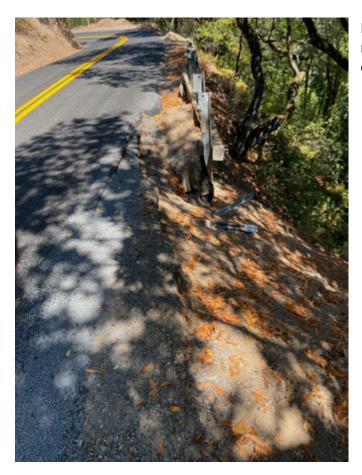
Repair location 4 – postmile 4.3 Earlier repair that needs new wood and extension to cover undermining shoulder.

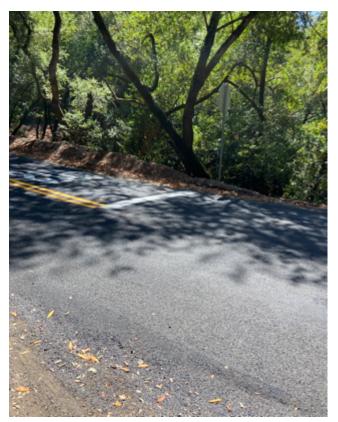
Repair location 5 – postmile 4.2 This is the long-term narrow spot that requires widening to remove the two-way stop. Right-of-way issues may be involved as well as possible grading and reinforced wall on the uphill side. Relatively low priority.

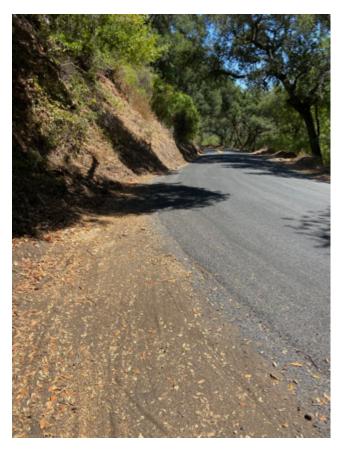
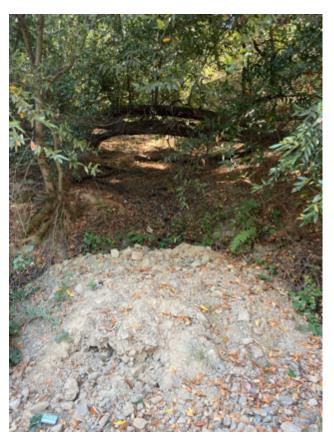
Repair location 6 – postmile 0.3 excess soil has been placed over a likely culvert opening and creek crossing. This situation prevents easy maintenance and could cause mud closing of road in a big rainstorm. Relatively low priority.
